# Calder Creek Restoration at Ives Park

- Project Goal
- Walking Tour
- Cautionary tales for Calder creek
- Restoration planning criteria
- Master Plan discussion

# Project Goals

- Conceptual Restoration Plan to restore geomorphic processes at Calder Creek
  - Build on Master Plan vision

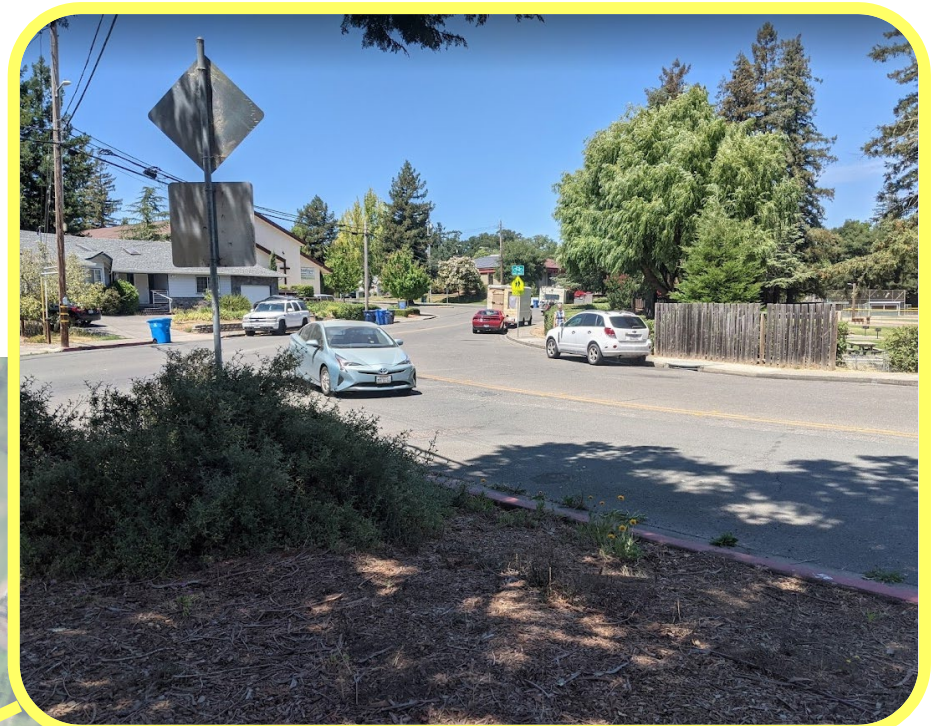
**At Jewell Avenue**

- Channelized creek
- Redwoods to edge
- Sewer line
- Fencing
- Protect stage area

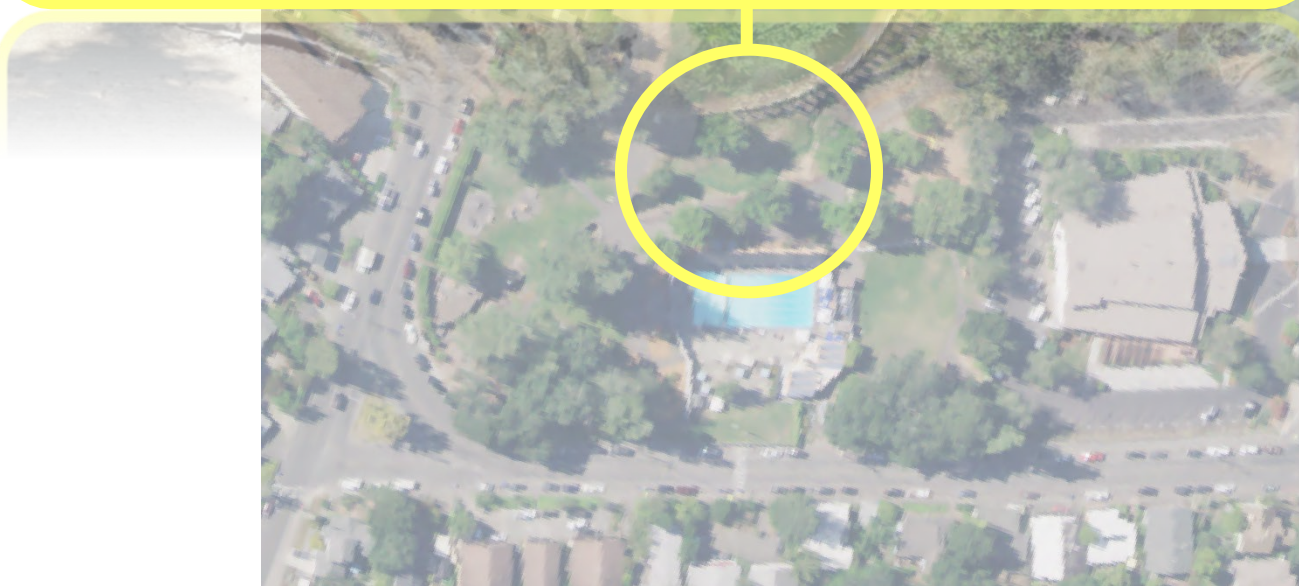
## By the swimming pool

- Historically ponded area = floodplain opportunity area
- Ballfields & Pool – firm edges

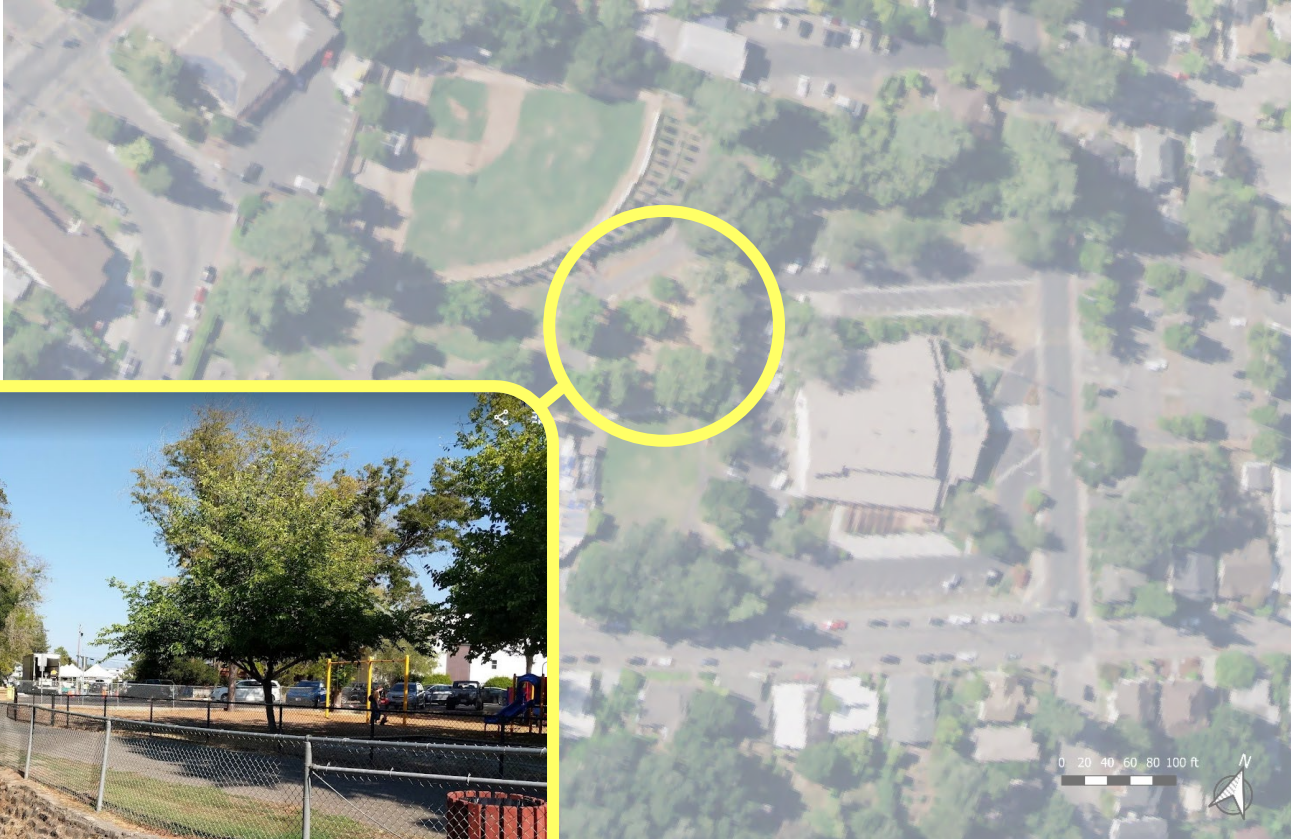
## Near the playground

- Channelized creek
- Play area flooding
- Fencing-visual barrier

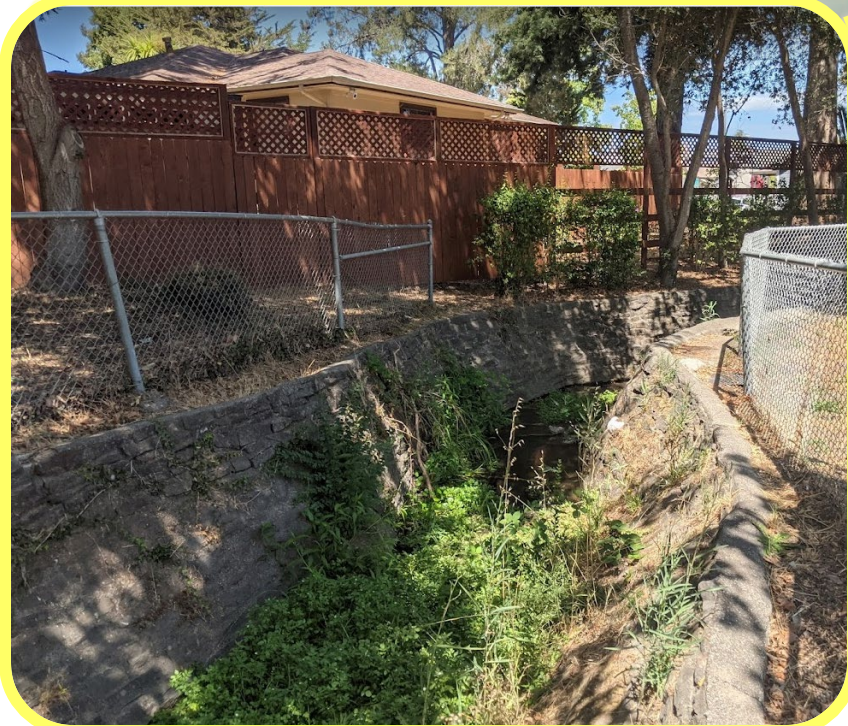
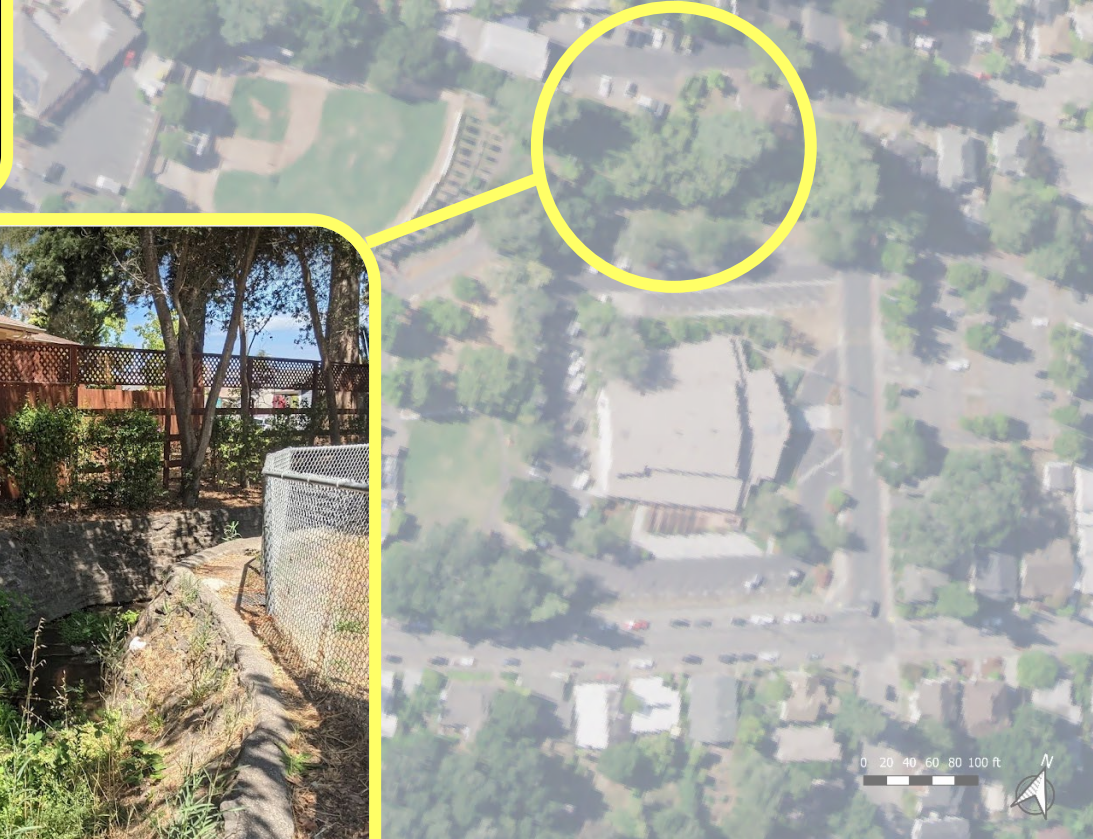
## Approaching High Street

- Channelized creek
- Oaks to channel edge
- Creek close to property boundary
- Fencing-visual barrier

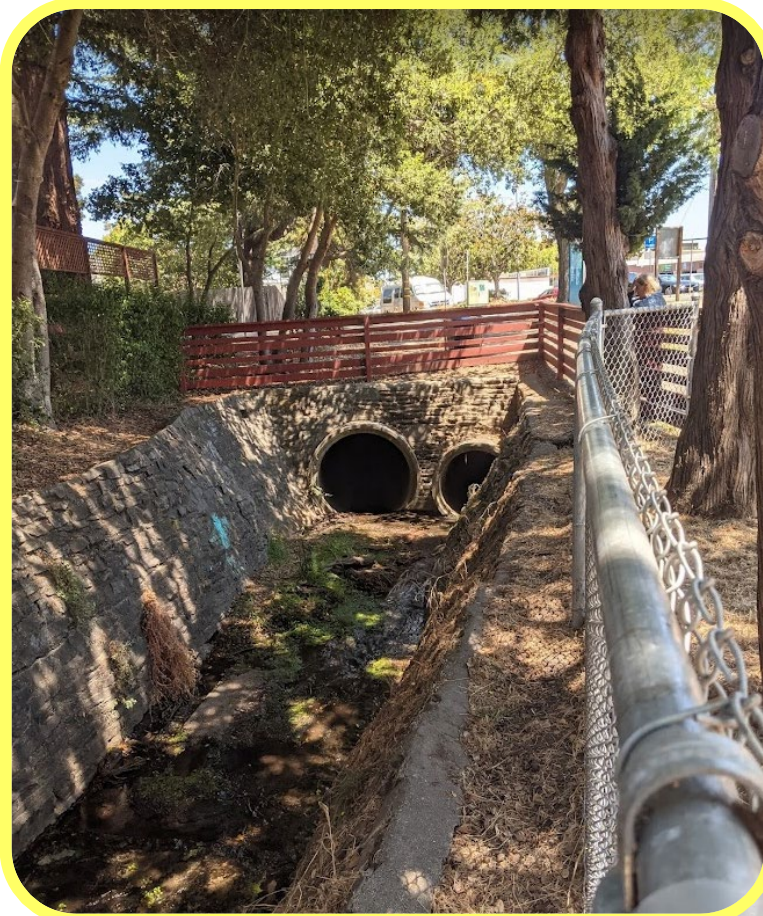
- Channelized creek
  - Culverted creek
  - Culvert size
- ## Approaching High Street

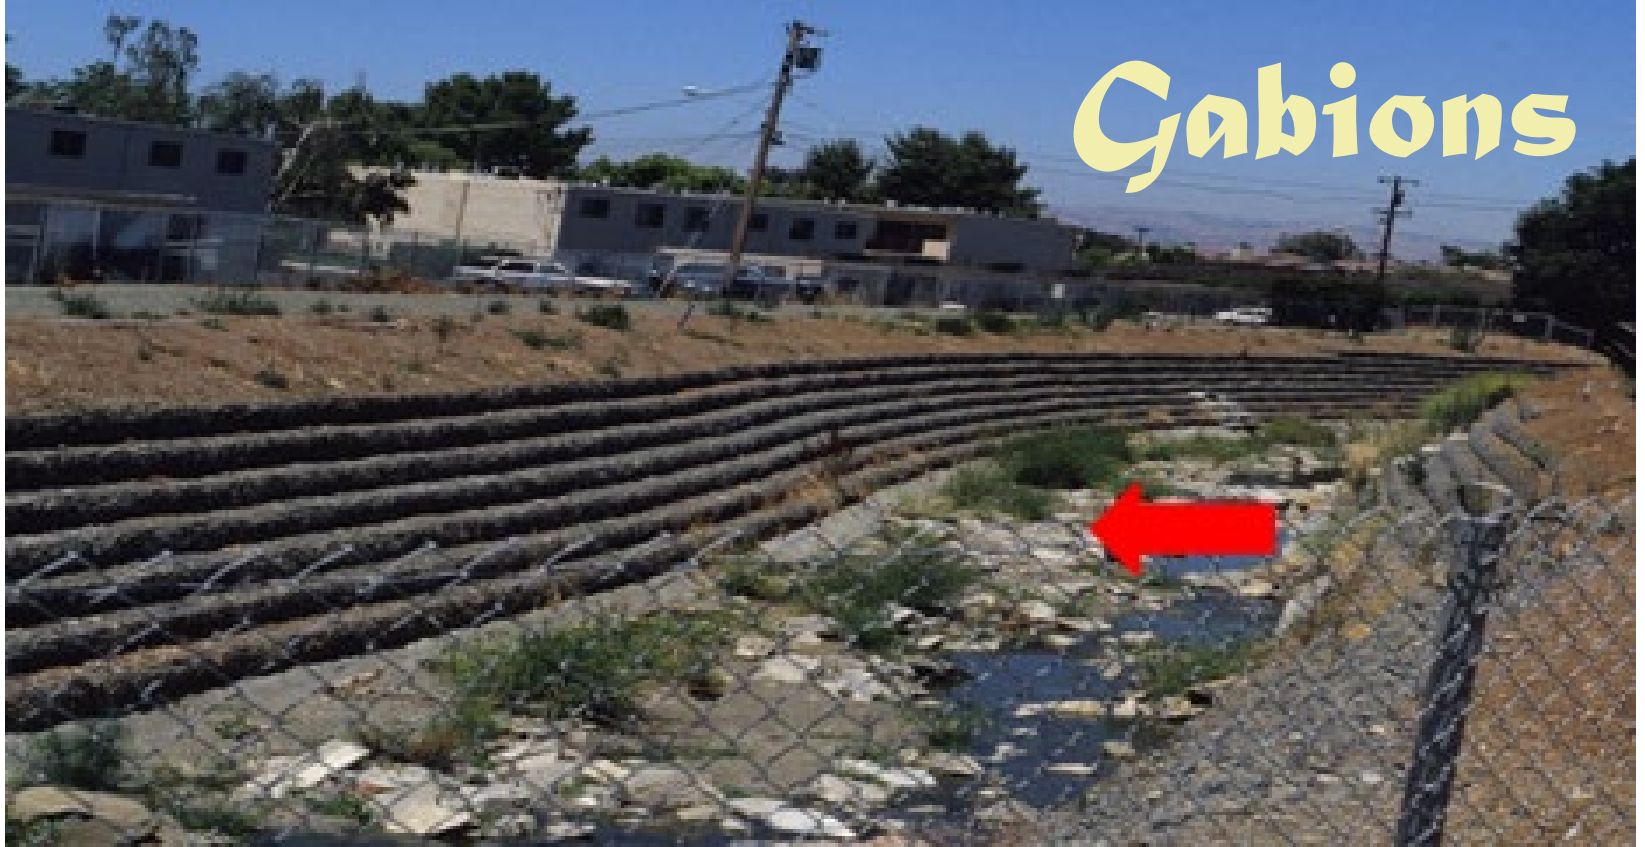
## GABION BANK FAILURE

Gabions created the conditions for channel incision

Project Invert. Exposes apron supporting gabions

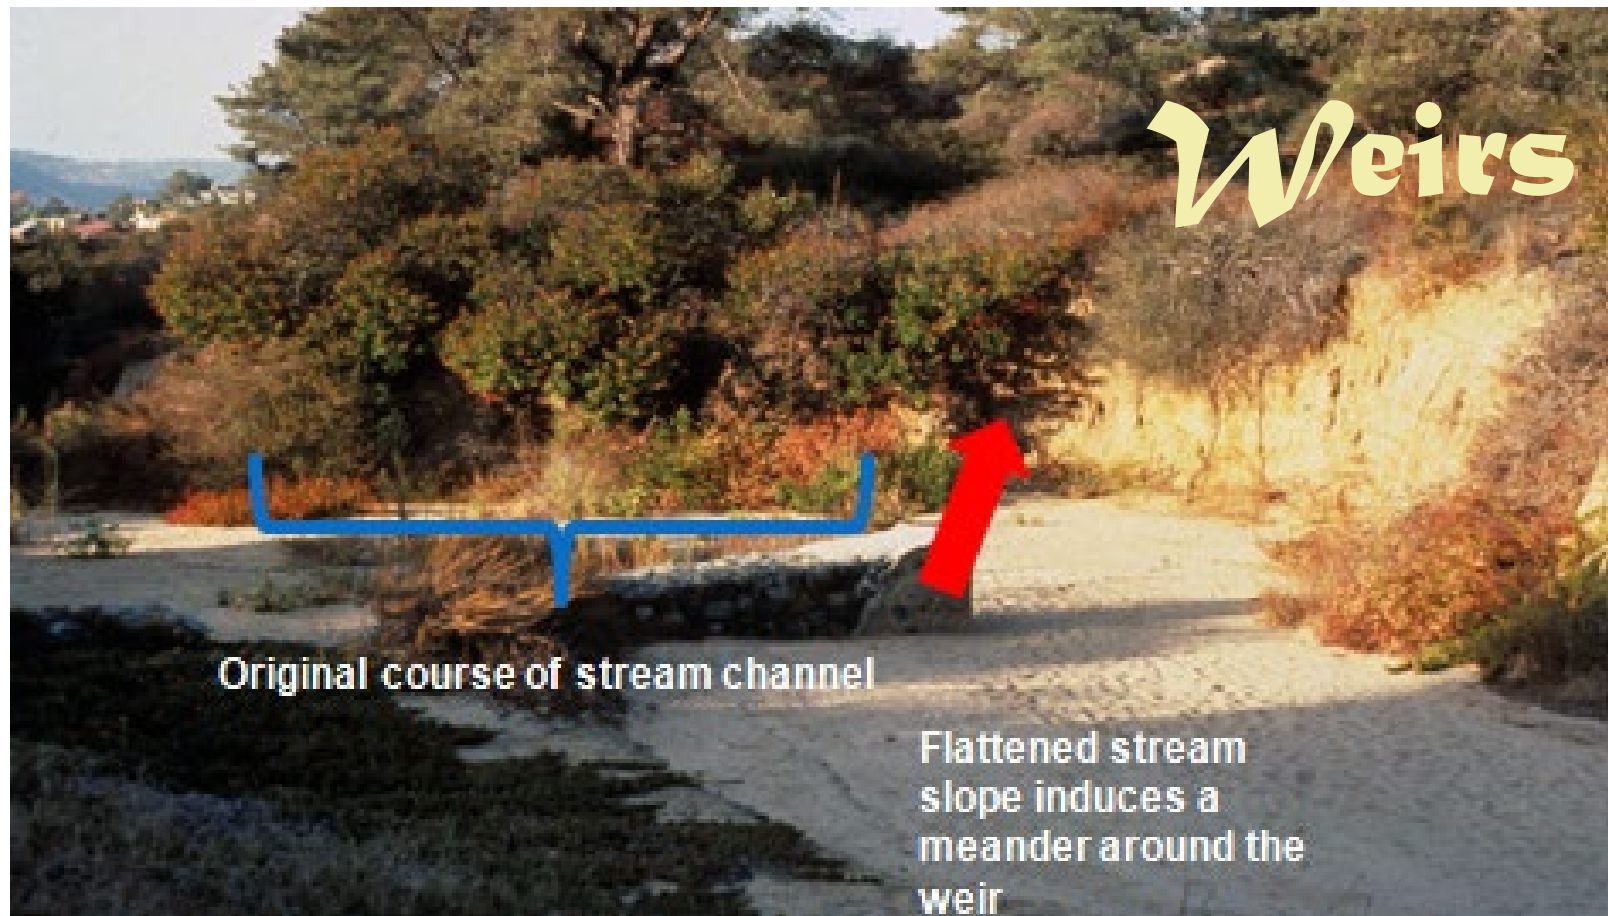
**A weir often flattens the stream slope and creates re-meandering of the stream which flanks the weir**

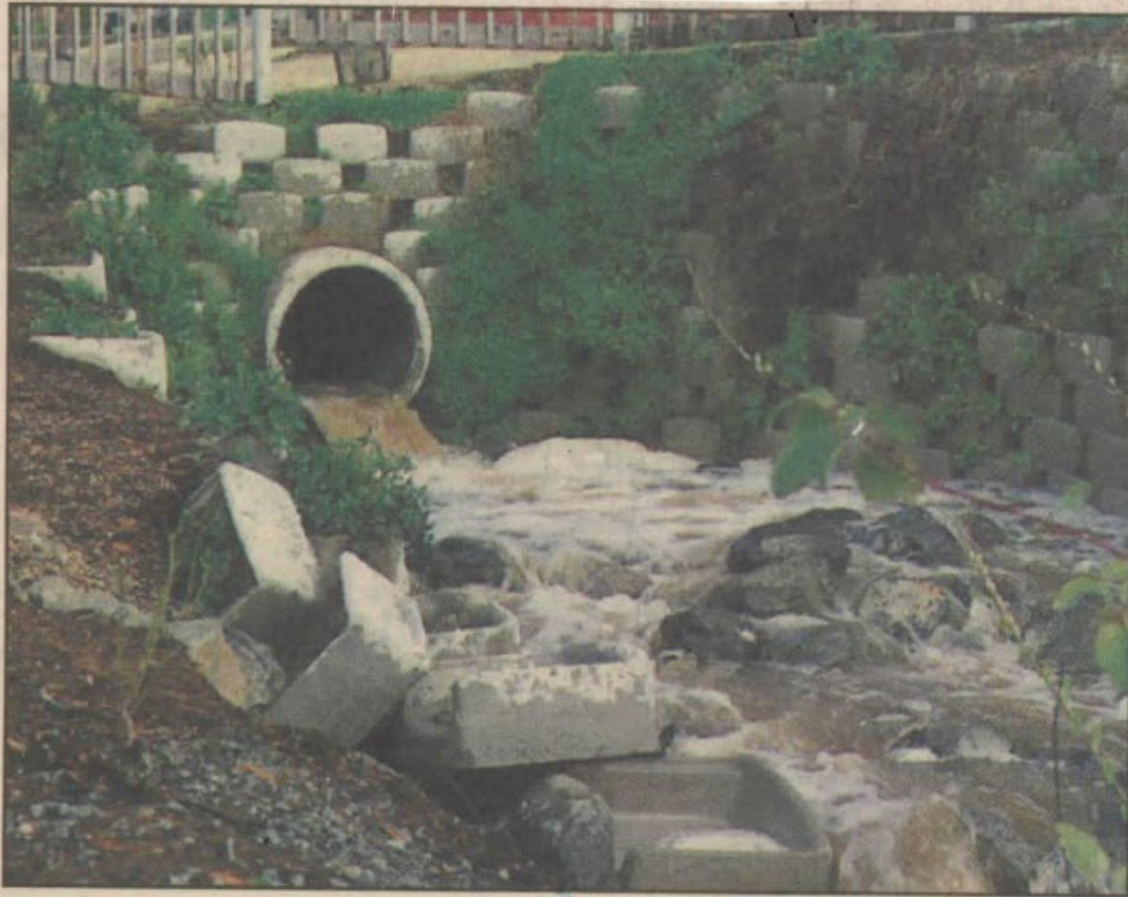
Above, El Niño added a pool to Arlington Park — under the swing set. Center, a tree's roots gave way on the rain-weakened hillside on Galvin Drive, taking power and cable TV lines with it. The tree was just one of the storm season's casualties. Left, the precipitation also proved too much for the concrete planters on this portion of creek in Poinsett Park.

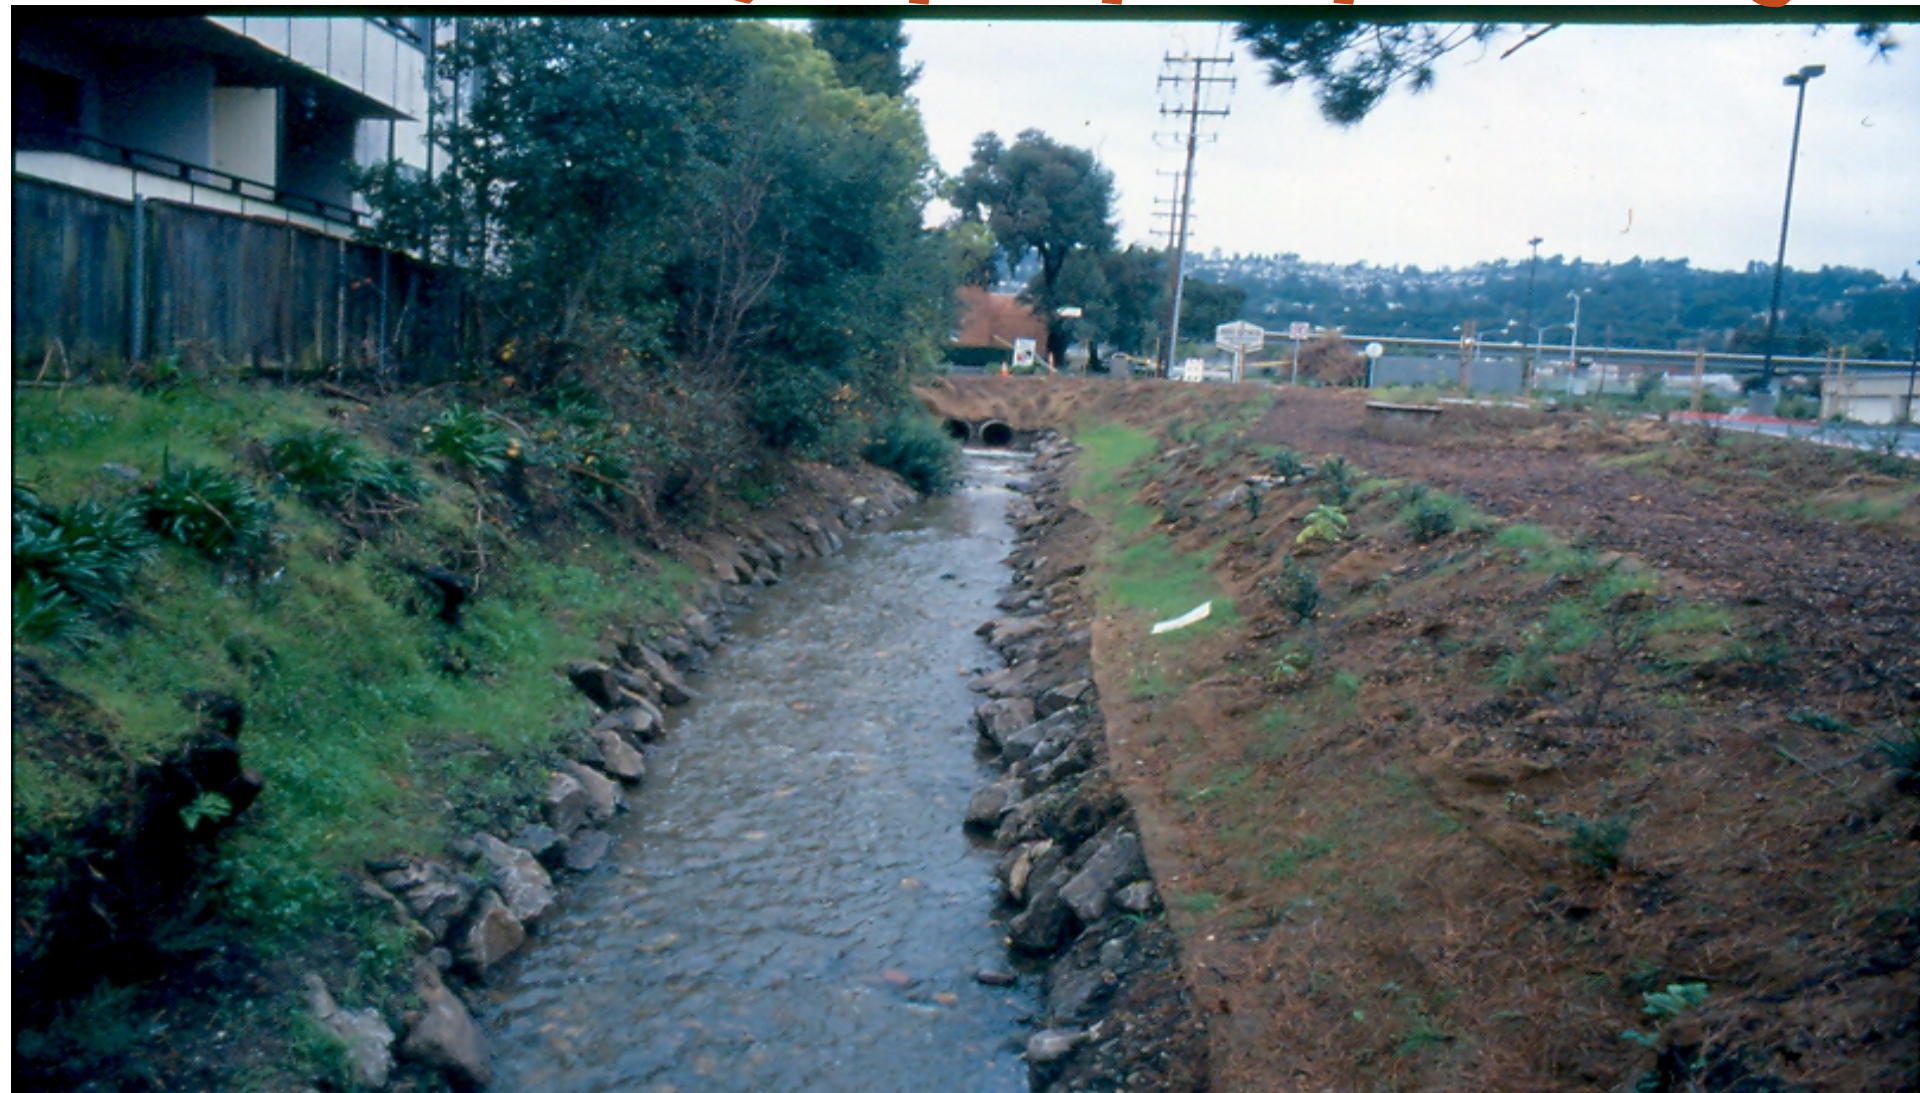
Rock gardening failure

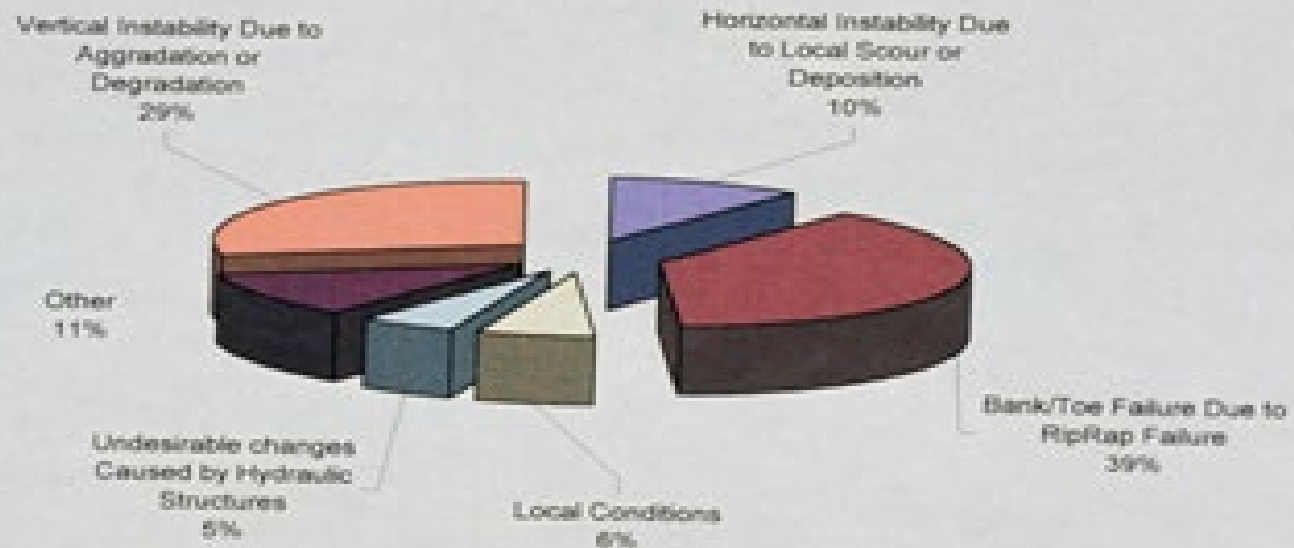
# ARMY CORPS STUDY ON REASONS FOR PROJECT FAILURES- 1990

## Common Post Construction Problems

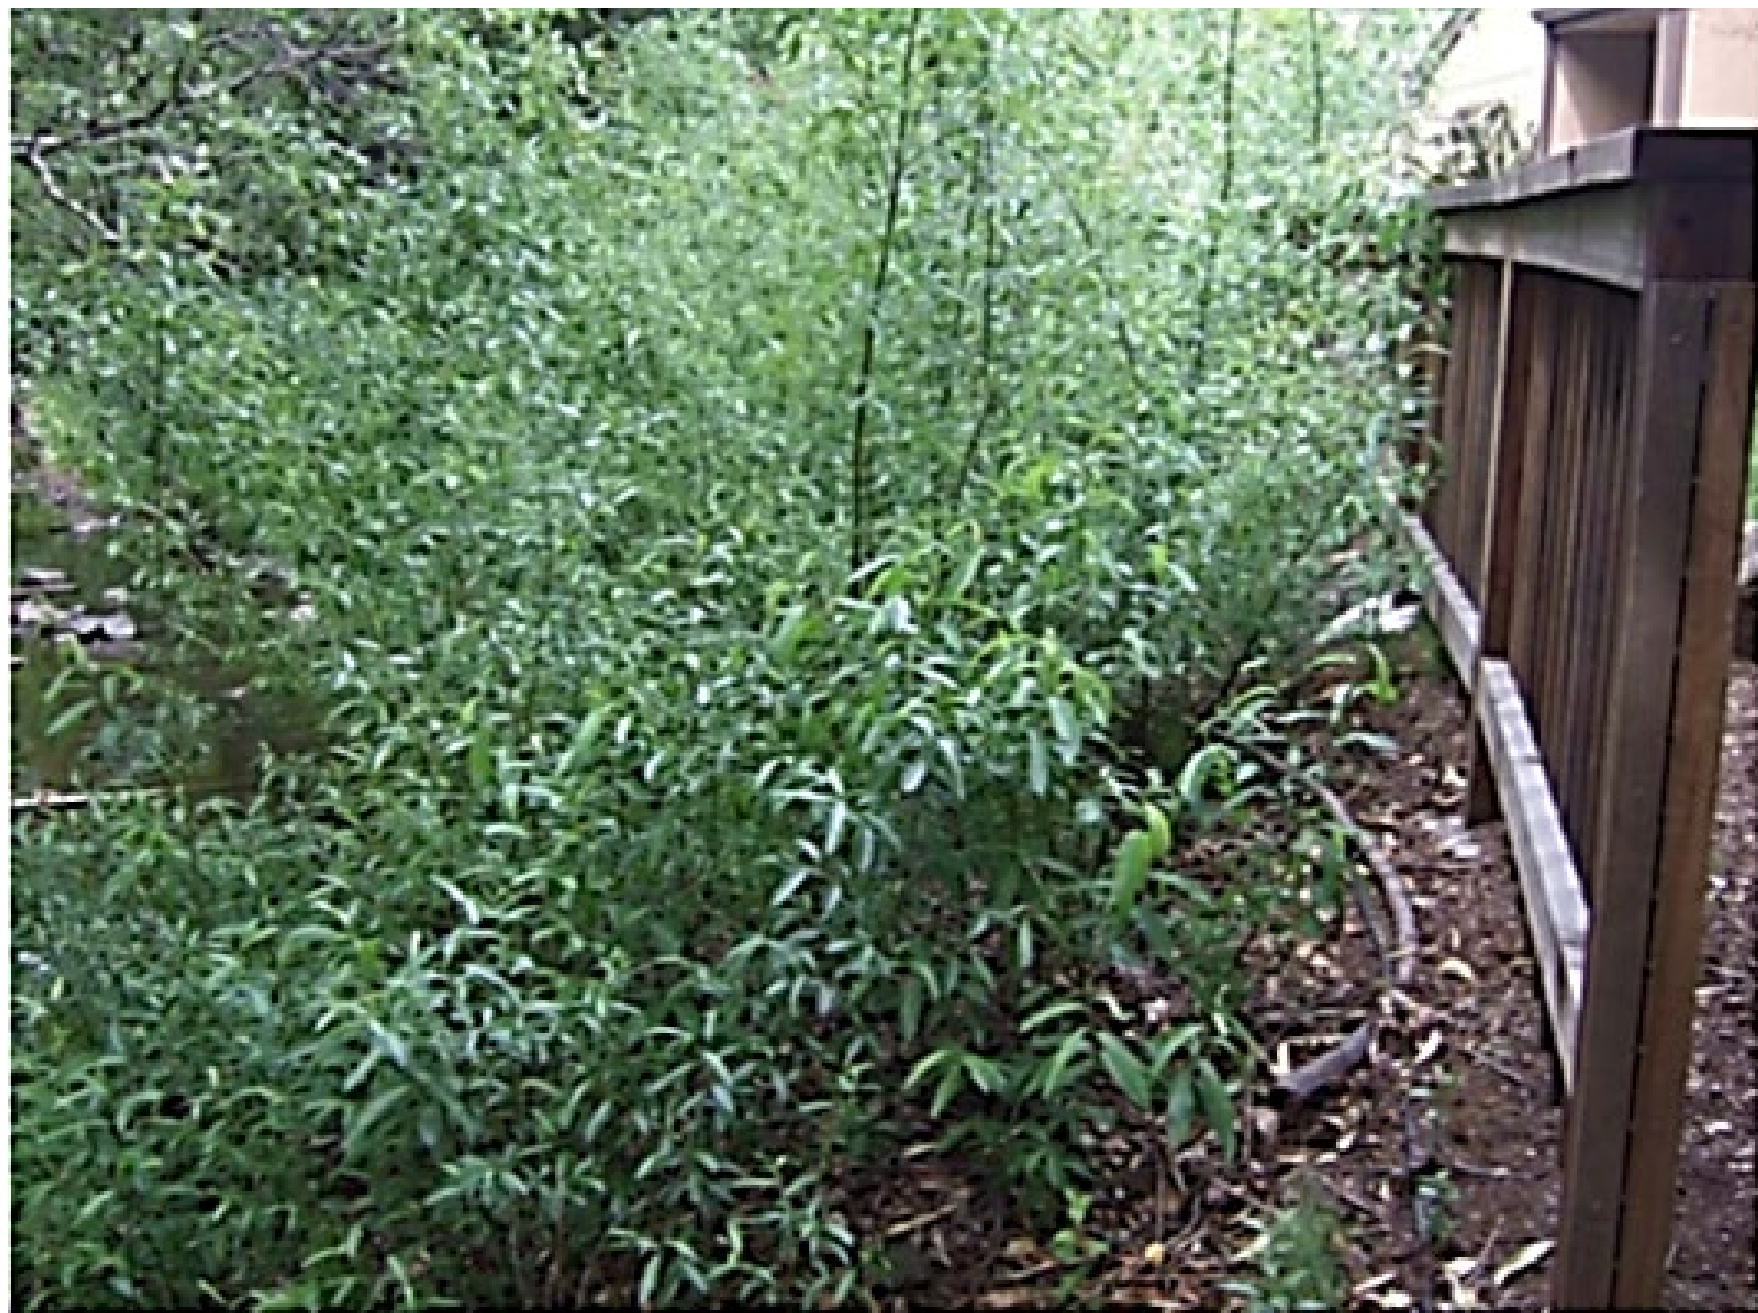
***Viewpoint 2. April 2015 photo looking upstream to bank erosion reduction project completed December 2013***

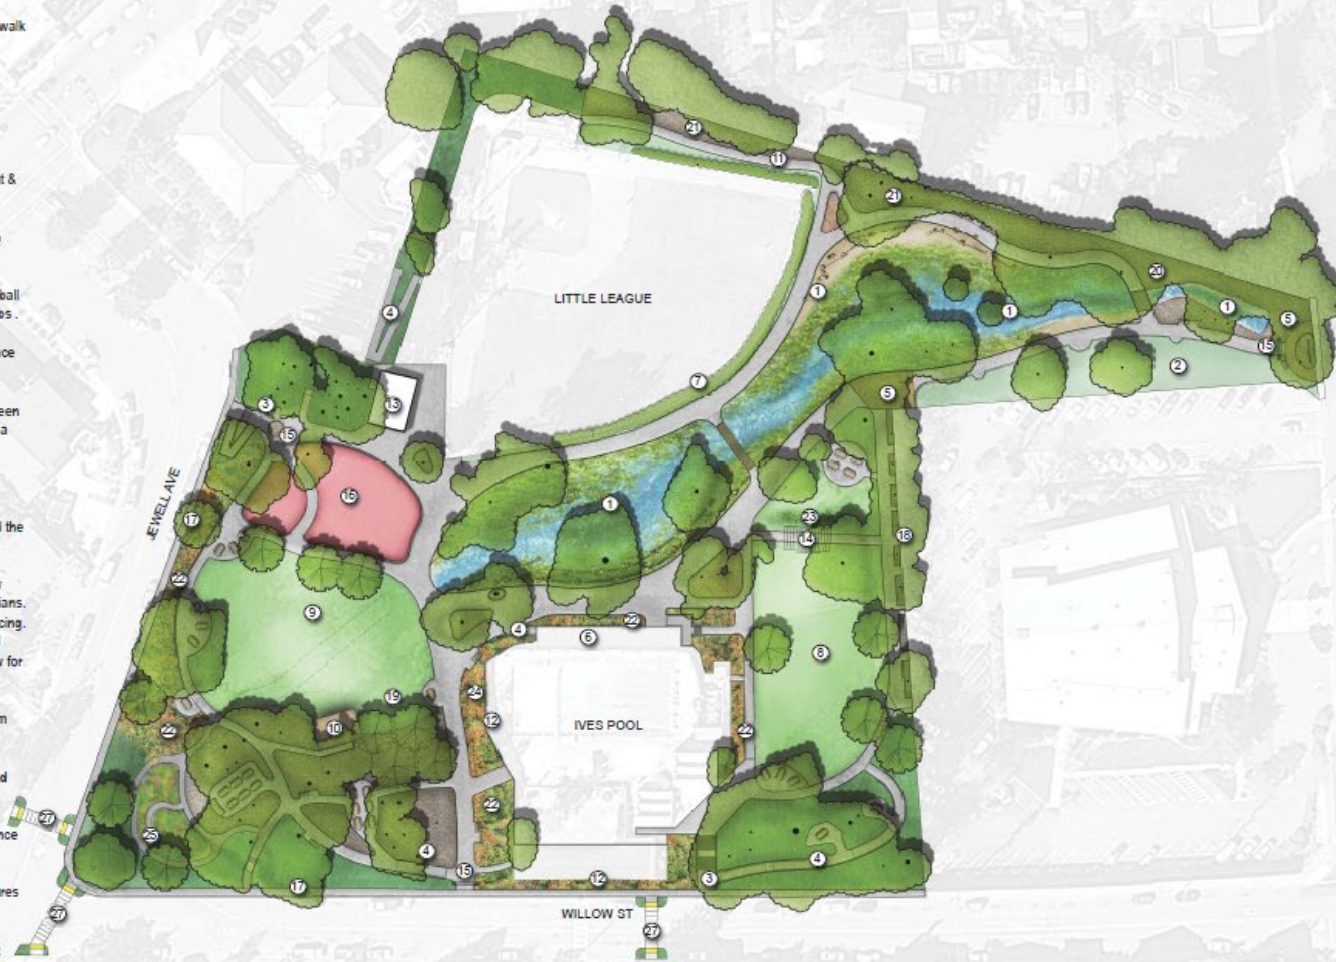
1. Remove chain link fencing & guardrails. Remove safety hazards from creek walls. Patch and repair creek wall as necessary. Restore natural channel in meadow area and rose garden area; underground creek in picnic area. Expand to rose garden area. Remove central bridge and relocate northern bridge. Add natural creek edge and seating.

9. Cap creek to form a large central green space and relocate picnic areas along a new perimeter walk.
