City of Sebastopol Design Review Board/Tree Board Staff Report

Meeting Date: January 27, 2026
Agenda Item: 6A
To: Design Review & Tree Board
From: Victoria Henkel, Permit Technician
Subject: Tree Removal
Recommendation: Approval with Conditions
Applicant/Owner: Fine Tree Care/Iris Stuart
File Number: 2025-062
Address: 8196 Bodega Ave (APN 004-580-001)
CEQA Status: Exempt
General Plan: Commercial Office (CO)
Zoning: Office Commercial (CO)

Application (2025-062)

8196 Bodega Ave (APN 004-580-001)

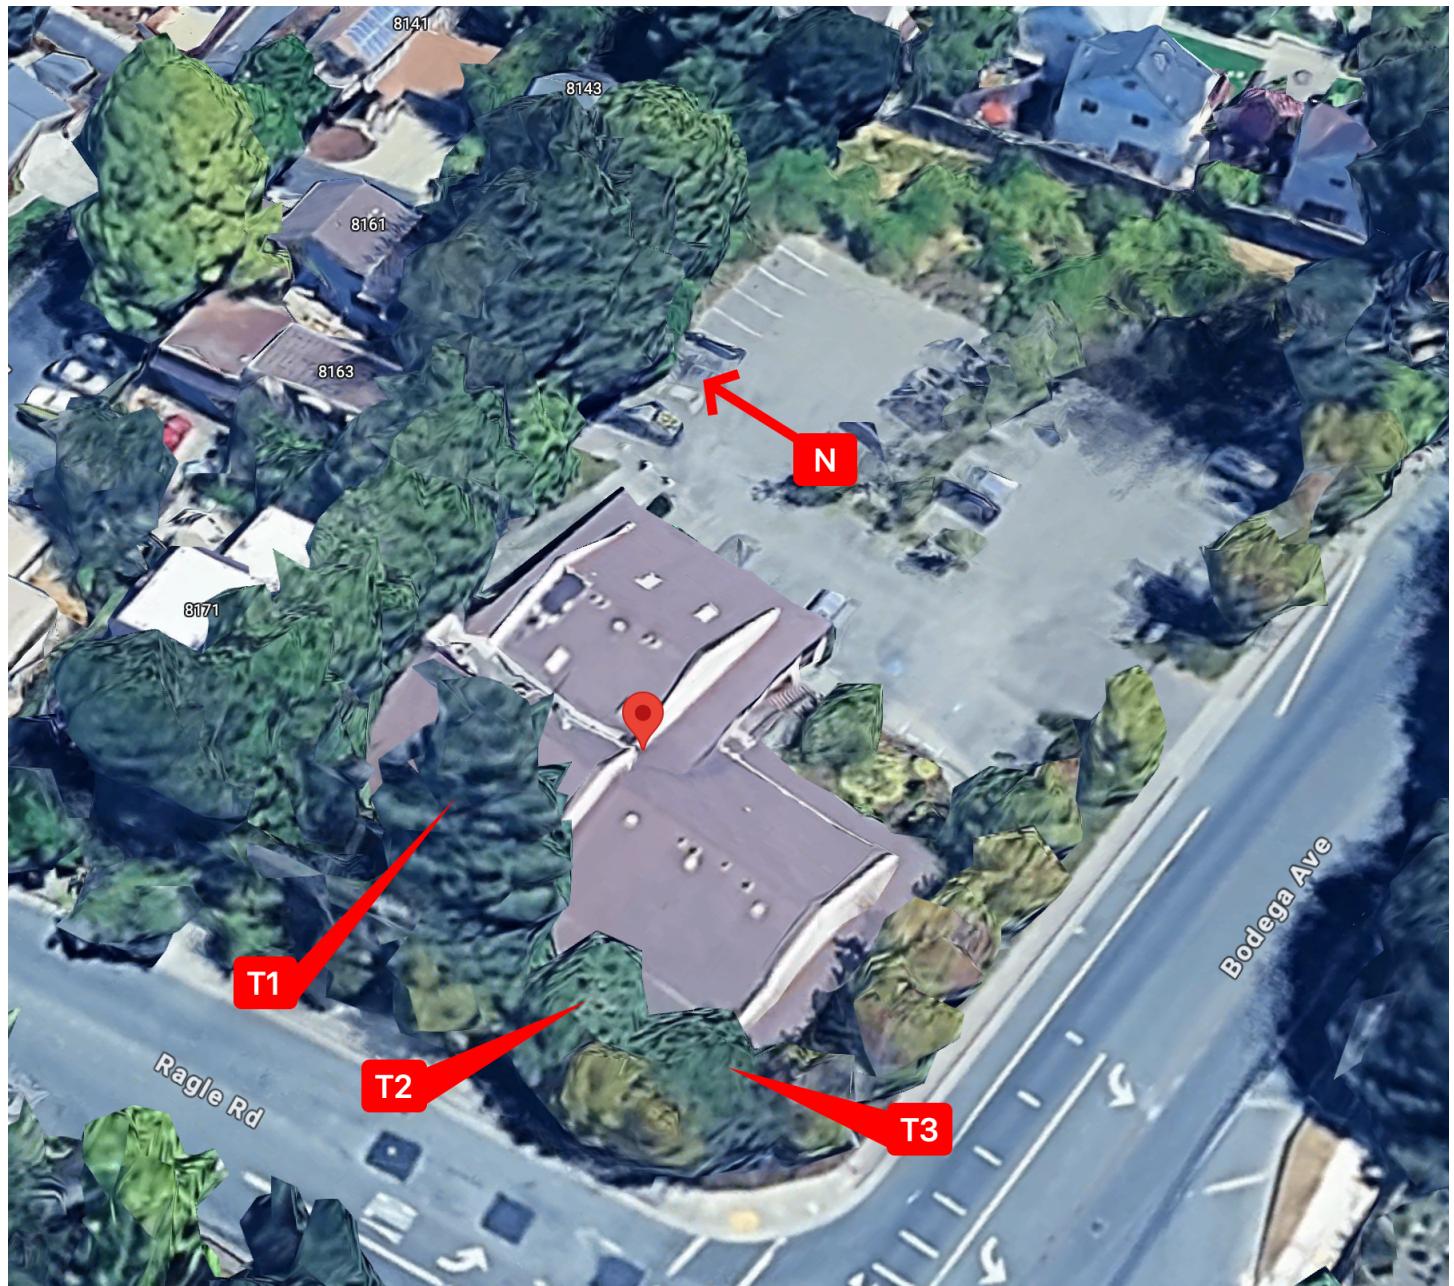
Figure 1. Oblique angle of the subject property from Google Maps showing the subject trees' locations.

The three subject trees are coast redwoods located between the building and Ragle Road. From north to south, their trunk diameters measured approximately 40.5 inches, 34 inches, and 23 inches. For clarity, I refer to these trees as Tree 1 through Tree 3, with Tree 1 being the largest and northernmost specimen.
