CITY OF SEBASTOPOL CITY COUNCIL
AGENDA ITEM REPORT FOR MEETING OF: February 17, 2026

To: Honorable Mayor and City Councilmembers
From: Toni Bertolero, Public Works Engineer
Erik Billing, Public Works Supervisor
Subject: Sebastopol Cultural Community Center – Short- and Long-Term Plan

Permanent Flood Proofing
 Agenda Item Number 8

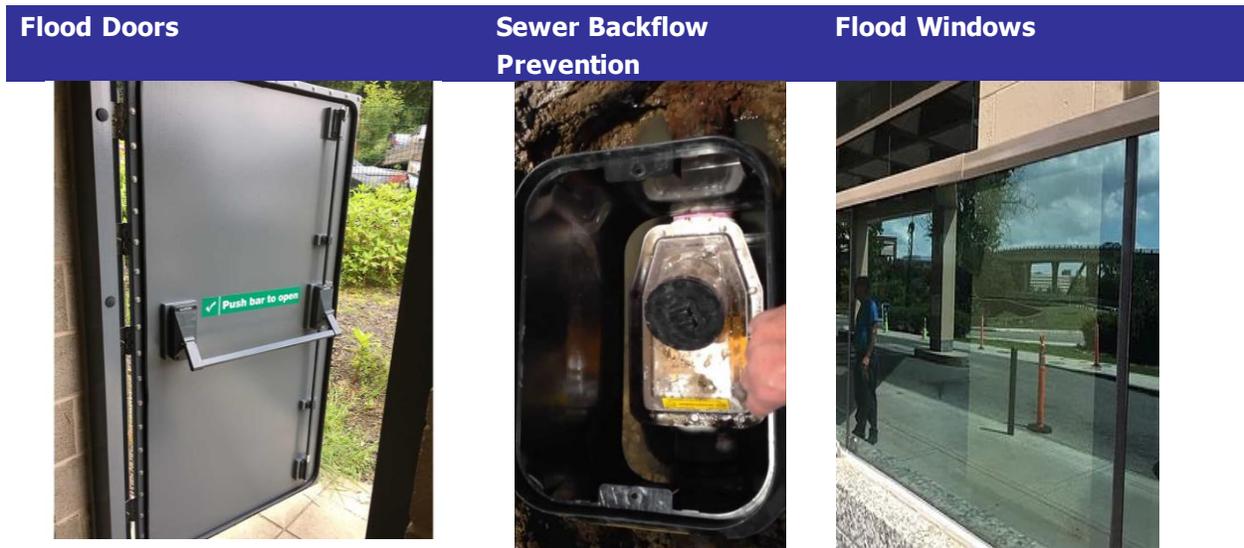
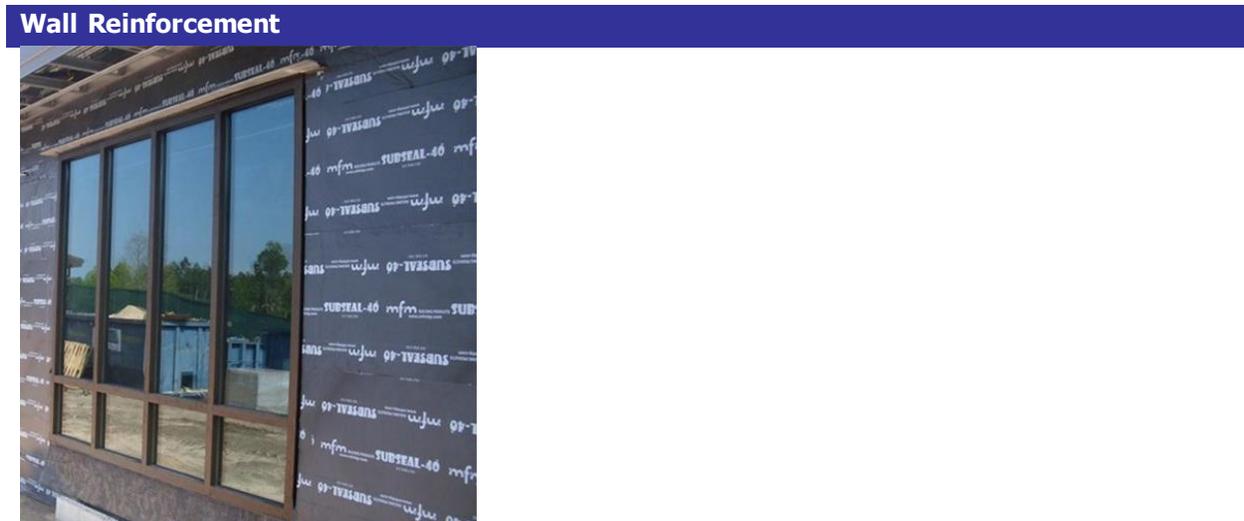
Figure 1: Permanent Dry Floodproofing Elements

Permanent measures will include the reinforcement of the corrugated metal walls with waterproof membrane wrapping. The level one standard door will be replaced with flood-resistant doors. Level one windows would be replaced with flood glass below the DFE. The walls supporting the windows will likely need to be structurally reinforced, as assumed herein. All utility penetrations into the structure below the DFE would be sealed using foam or polymer sealant. All vents into the structure on the first level would need to be sealed or replaced with automatically closing flood vents. Backflow prevention would be installed on all gravity utilities, specifically the sewer line upstream of the newly installed sand-oil interceptors. The electrical panel (with tankless water heater and generator equipment) will need to be elevated above the floodplain, so an electrician would need to be consulted.

Floodproofing Element	Location(s)	Quantity*
Reinforce Walls	Bottom 10' of building exterior walls	2,800 SF
Flood Doors	Standard Pedestrian Doors	6 EA
Flood Windows – Marine Glass	Standard Horizontal Sliding Doors	8 EA
Sewer Backflow Prevention	Sanitary Sewer laterals	1 EA
Elevate Electrical, Generator and Tankless Water Heater	Northwest corner of property	3 EA
Seal Wall & Ground Penetrations	Air conditioning units, water service, gas service, electrical services	10 EA

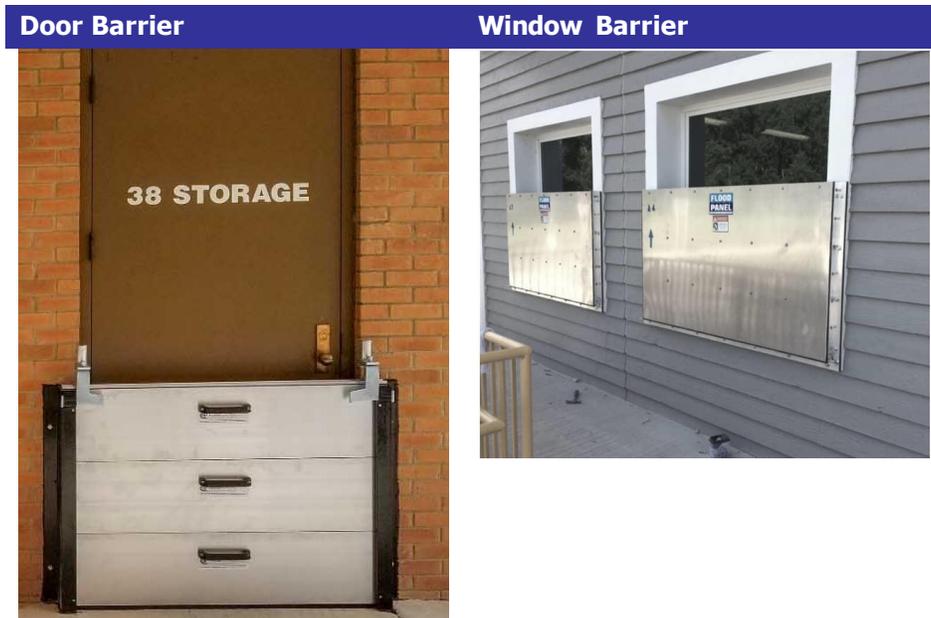
Figure 2: Temporary Dry Floodproofing Elements

Floodproofing Element	Location(s)	Quantity*
Reinforce Walls	Bottom 10' of building exterior walls	2,800 Square Feet (SF)
Active Door Barrier	Barrier for standard pedestrian doors	6 Each (EA)
Active Window Barrier	Barrier for horizontal sliding windows	8 EA
Active Barrier around electrical equipment	Northwest corner of property	35 Linear Feet (LF)
Sewer Backflow Prevention	Sanitary Sewer laterals	1 EA
Seal Wall & Ground Penetrations	Air conditioning units, water service, gas service, and electrical services	10 EA

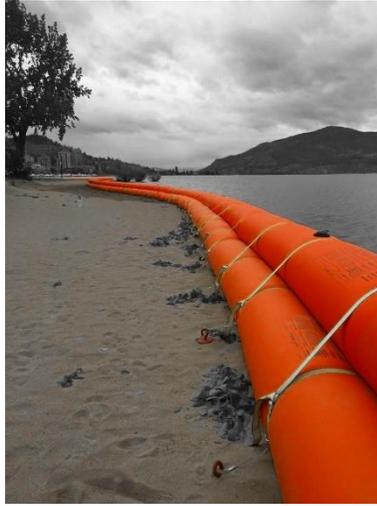
Figure 4: Removable Perimeter Barrier

Removable Perimeter Barrier

Based on the results, we recommend that a removable perimeter barrier be used since it is the most cost-efficient option and can provide the desired 10-feet of flood protection, when needed.

The study concluded that based on the results of their alternatives analysis, it was recommended that Alternative 4 consisting of a removable perimeter barrier be used since it is the most cost-efficient option and can provide the desired 10 feet of flood protection, when needed.

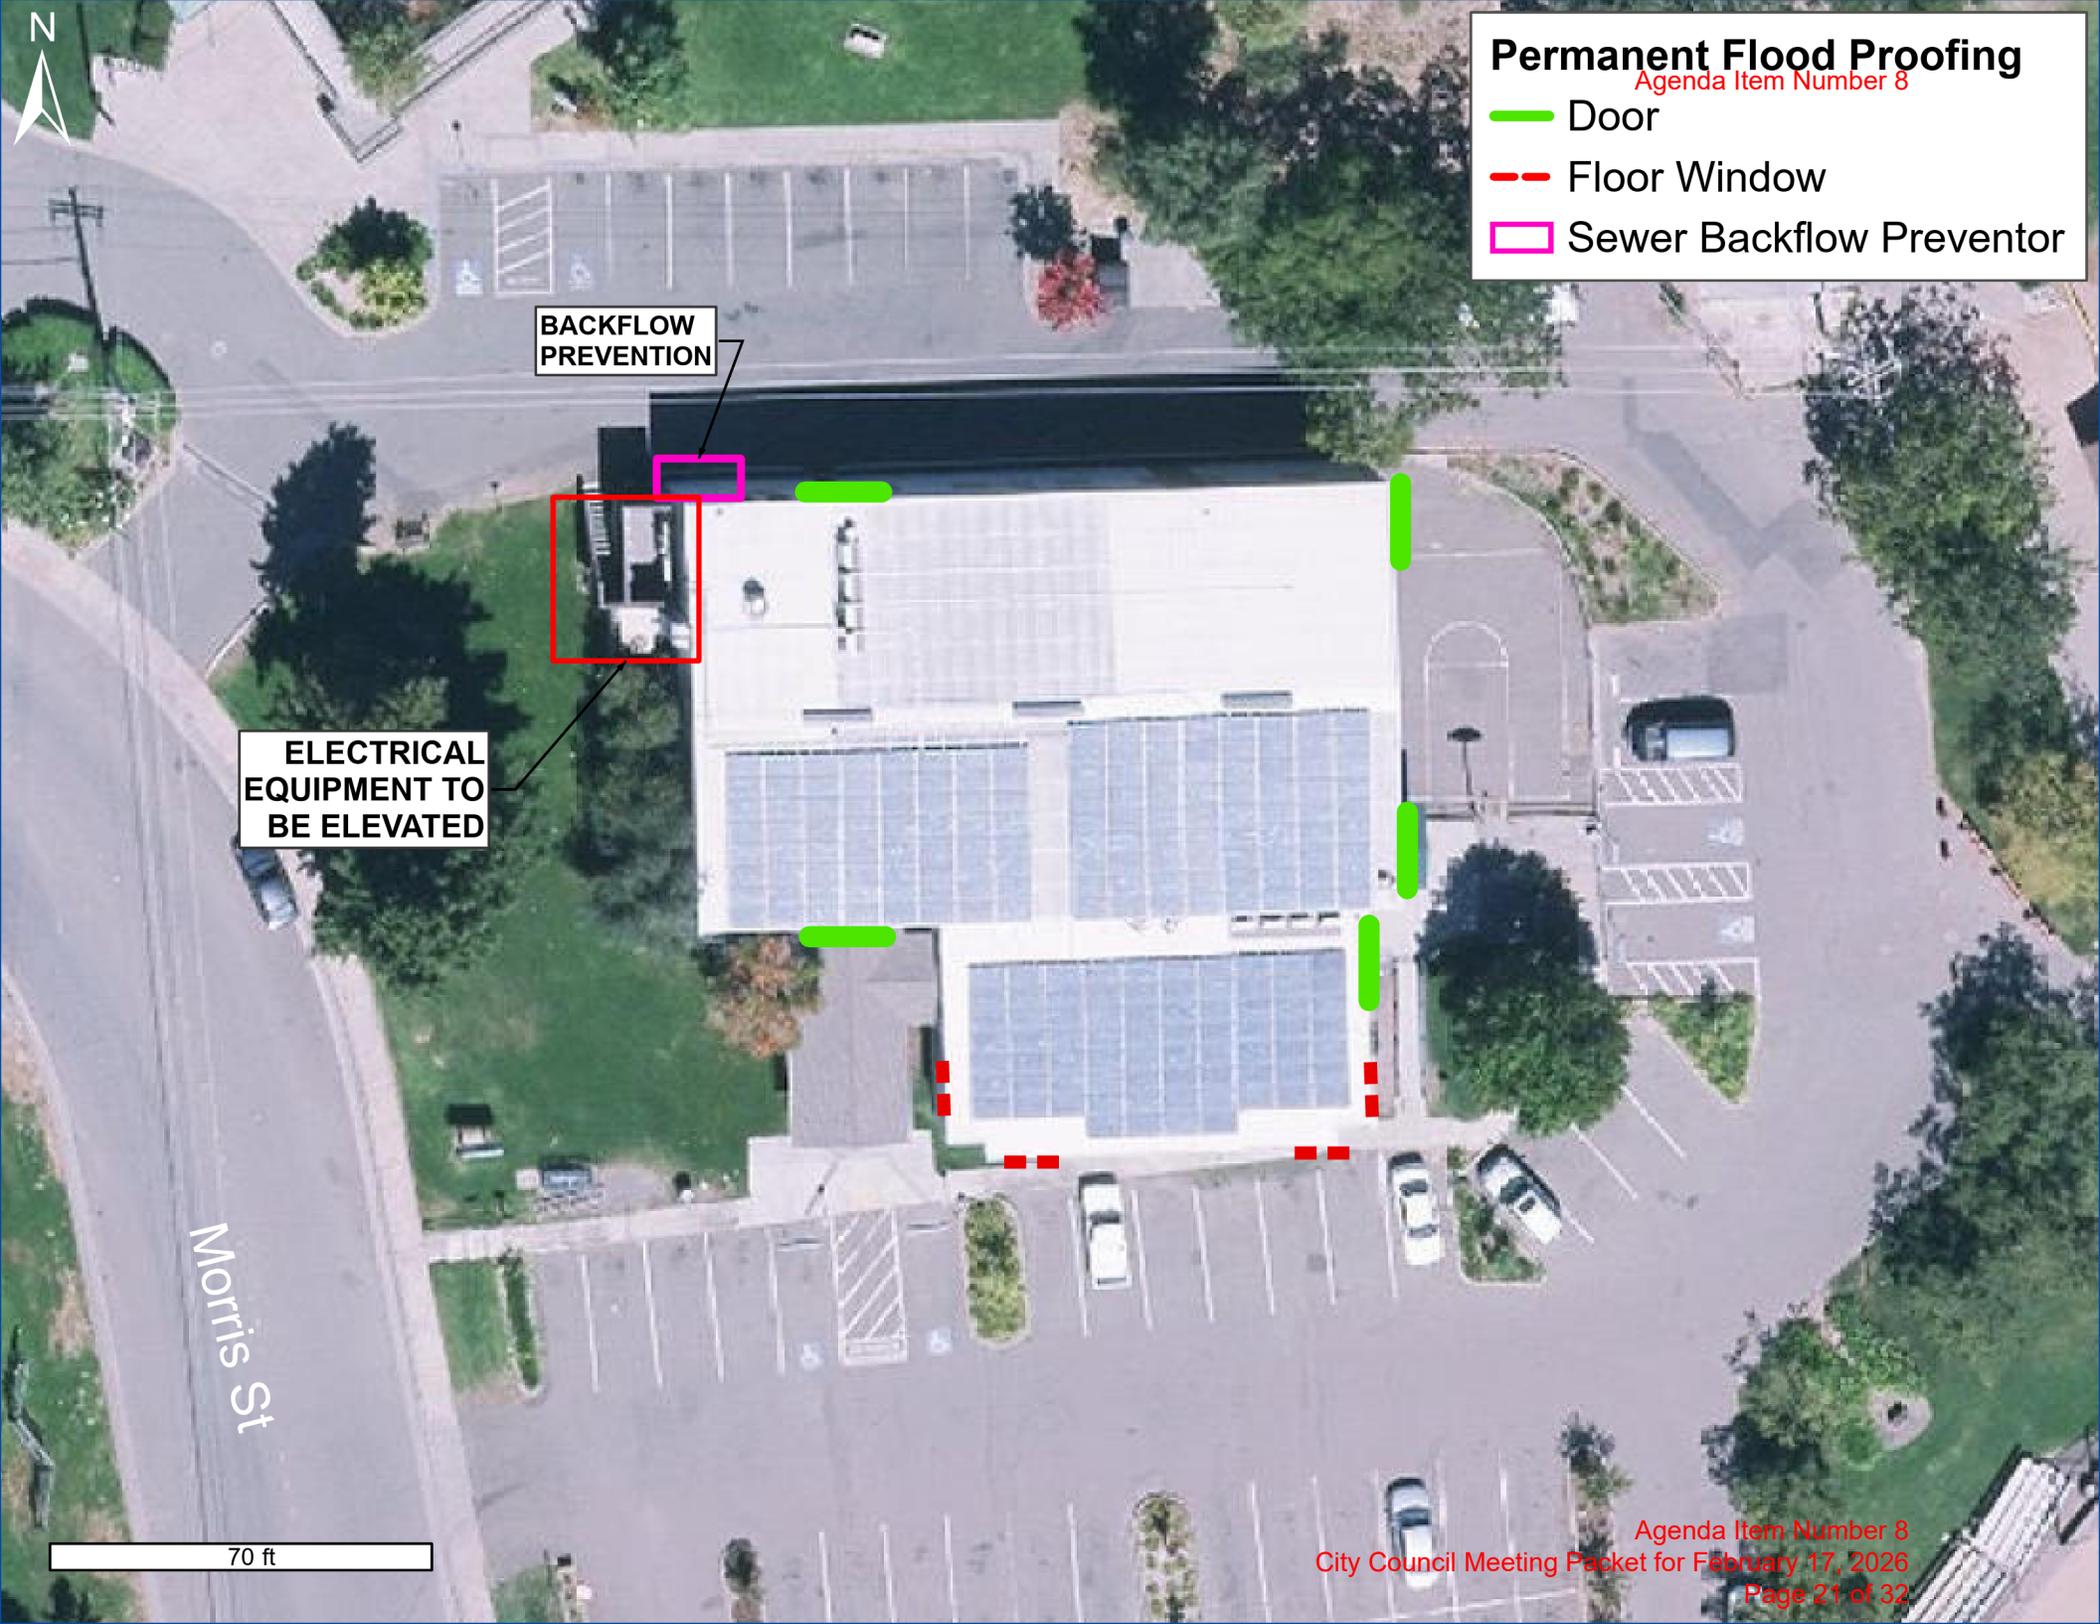
- Door
- - - Floor Window
- Sewer Backflow Preventor

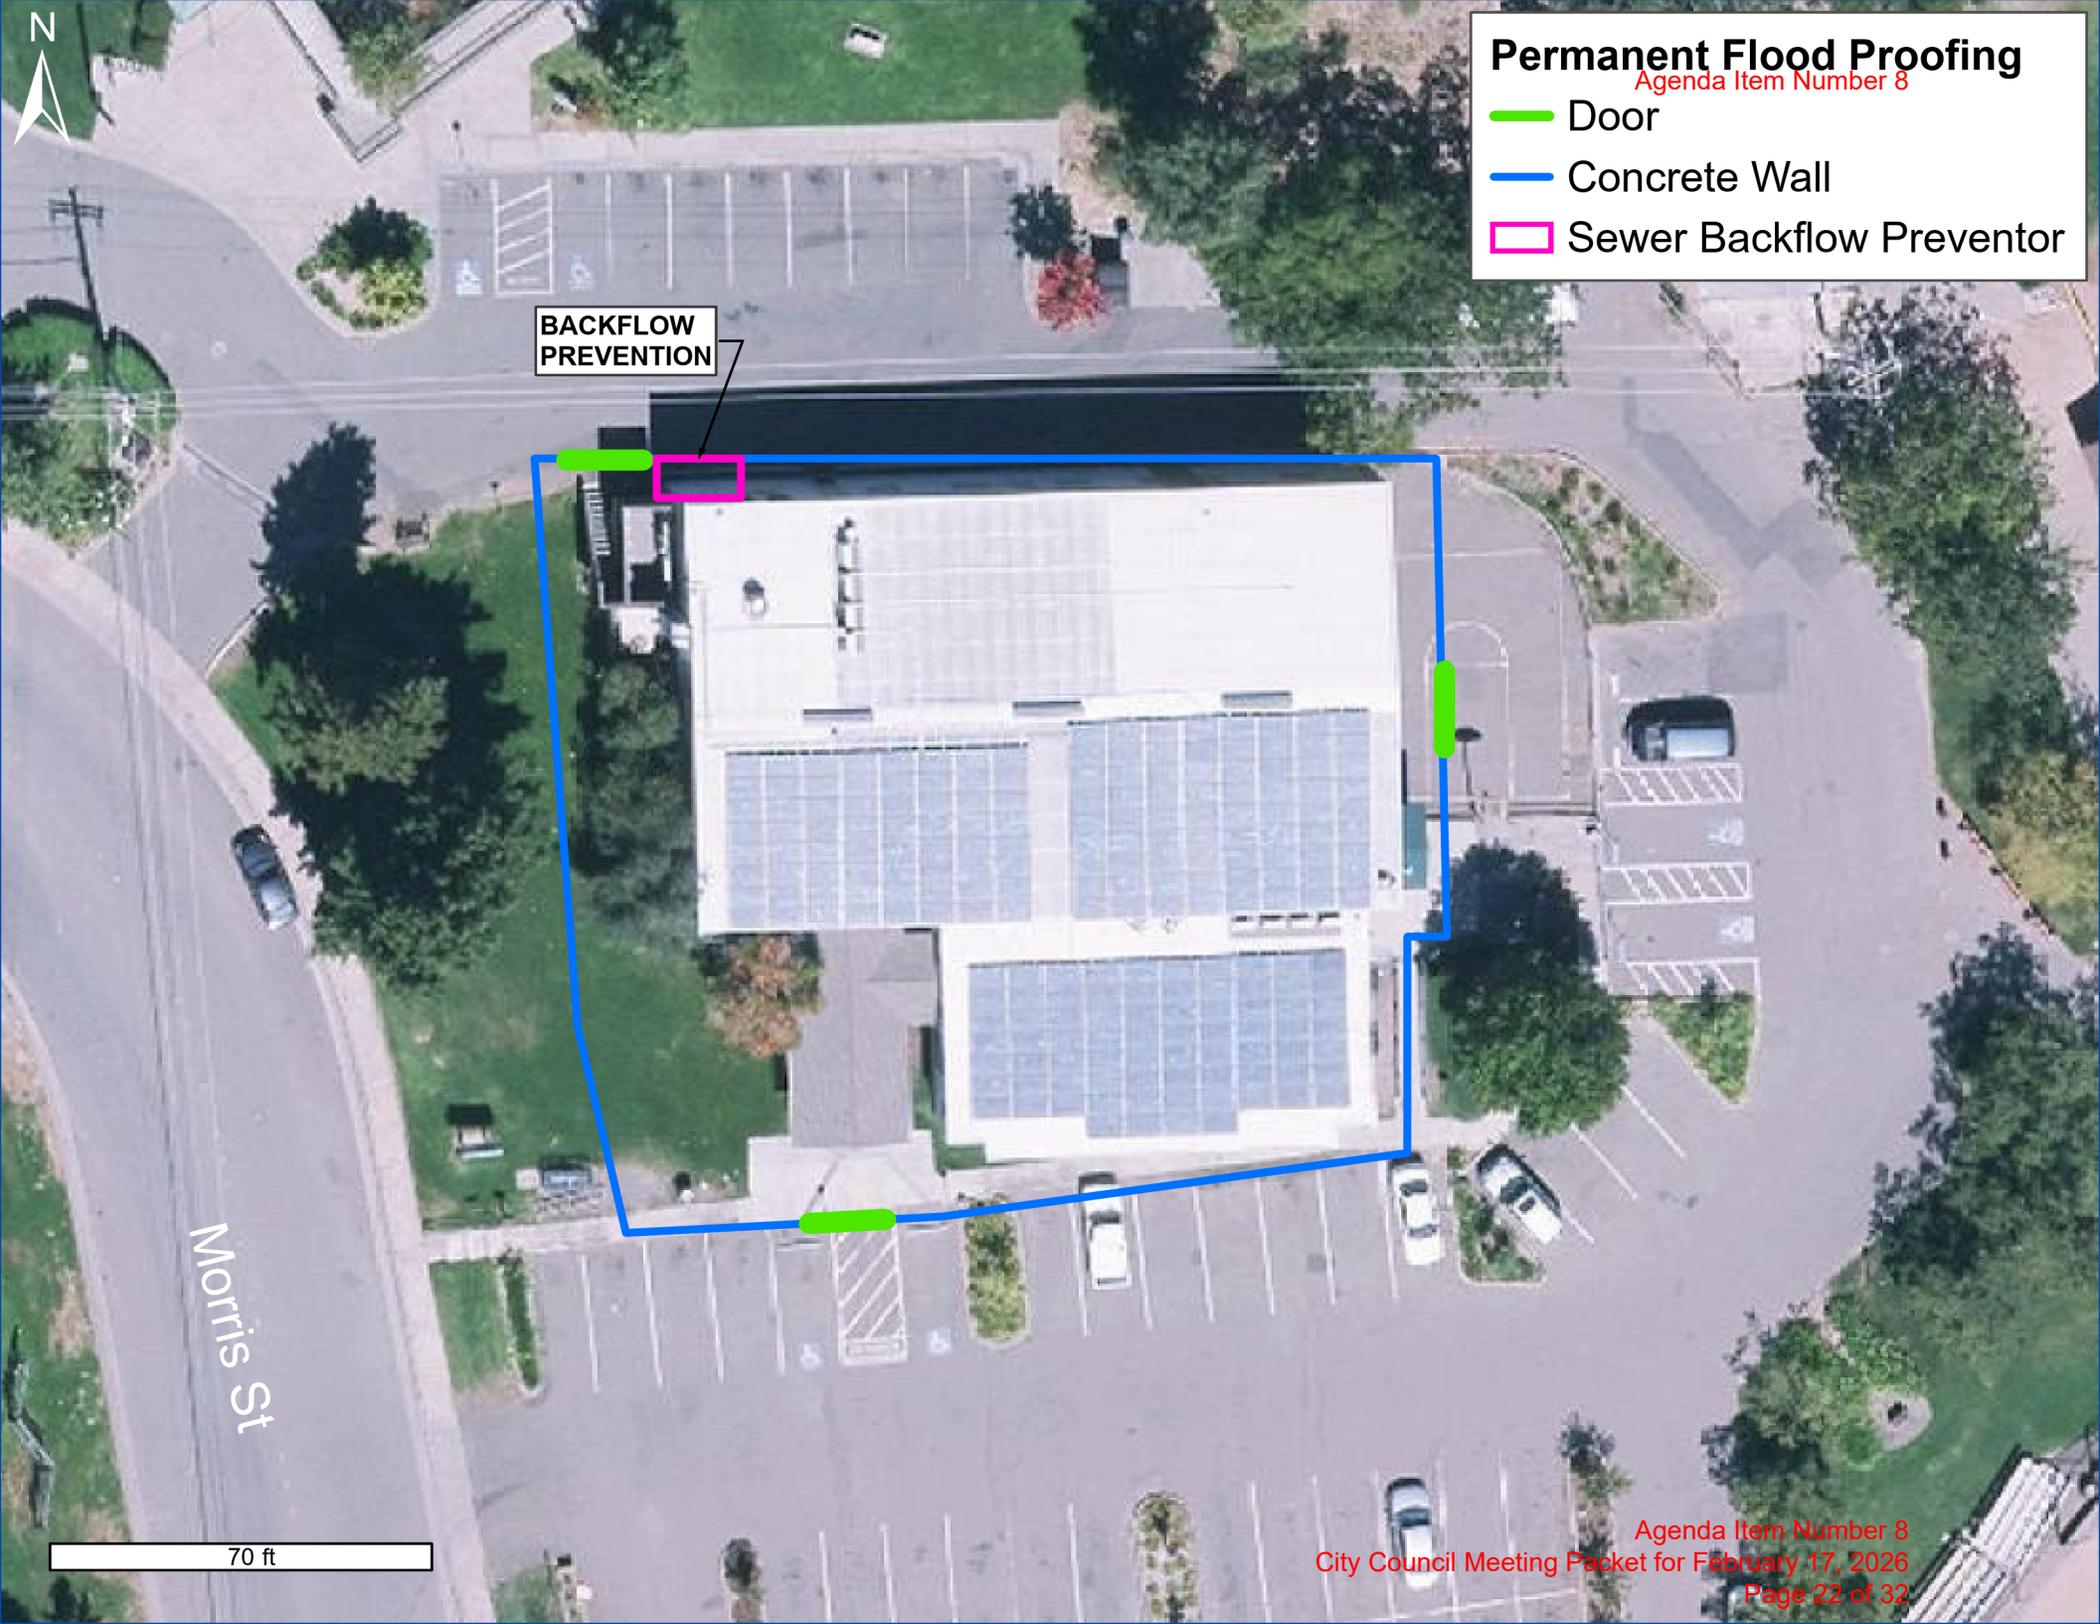
Permanent Flood Proofing
 Agenda Item Number 8

The second option is to install a ten-foot reinforced concrete wall with flood doors and no additional floodproofing measures directly applied to the structure. The concrete wall will be installed around the perimeter of the Community Center as close as possible to reduce the concrete wall footprint and not obstruct the parking lot. Three flood doors will be installed for pedestrian access into the site. Backflow prevention on the sewer lateral is also recommended.

- Door
- Concrete Wall
- Sewer Backflow Preventor

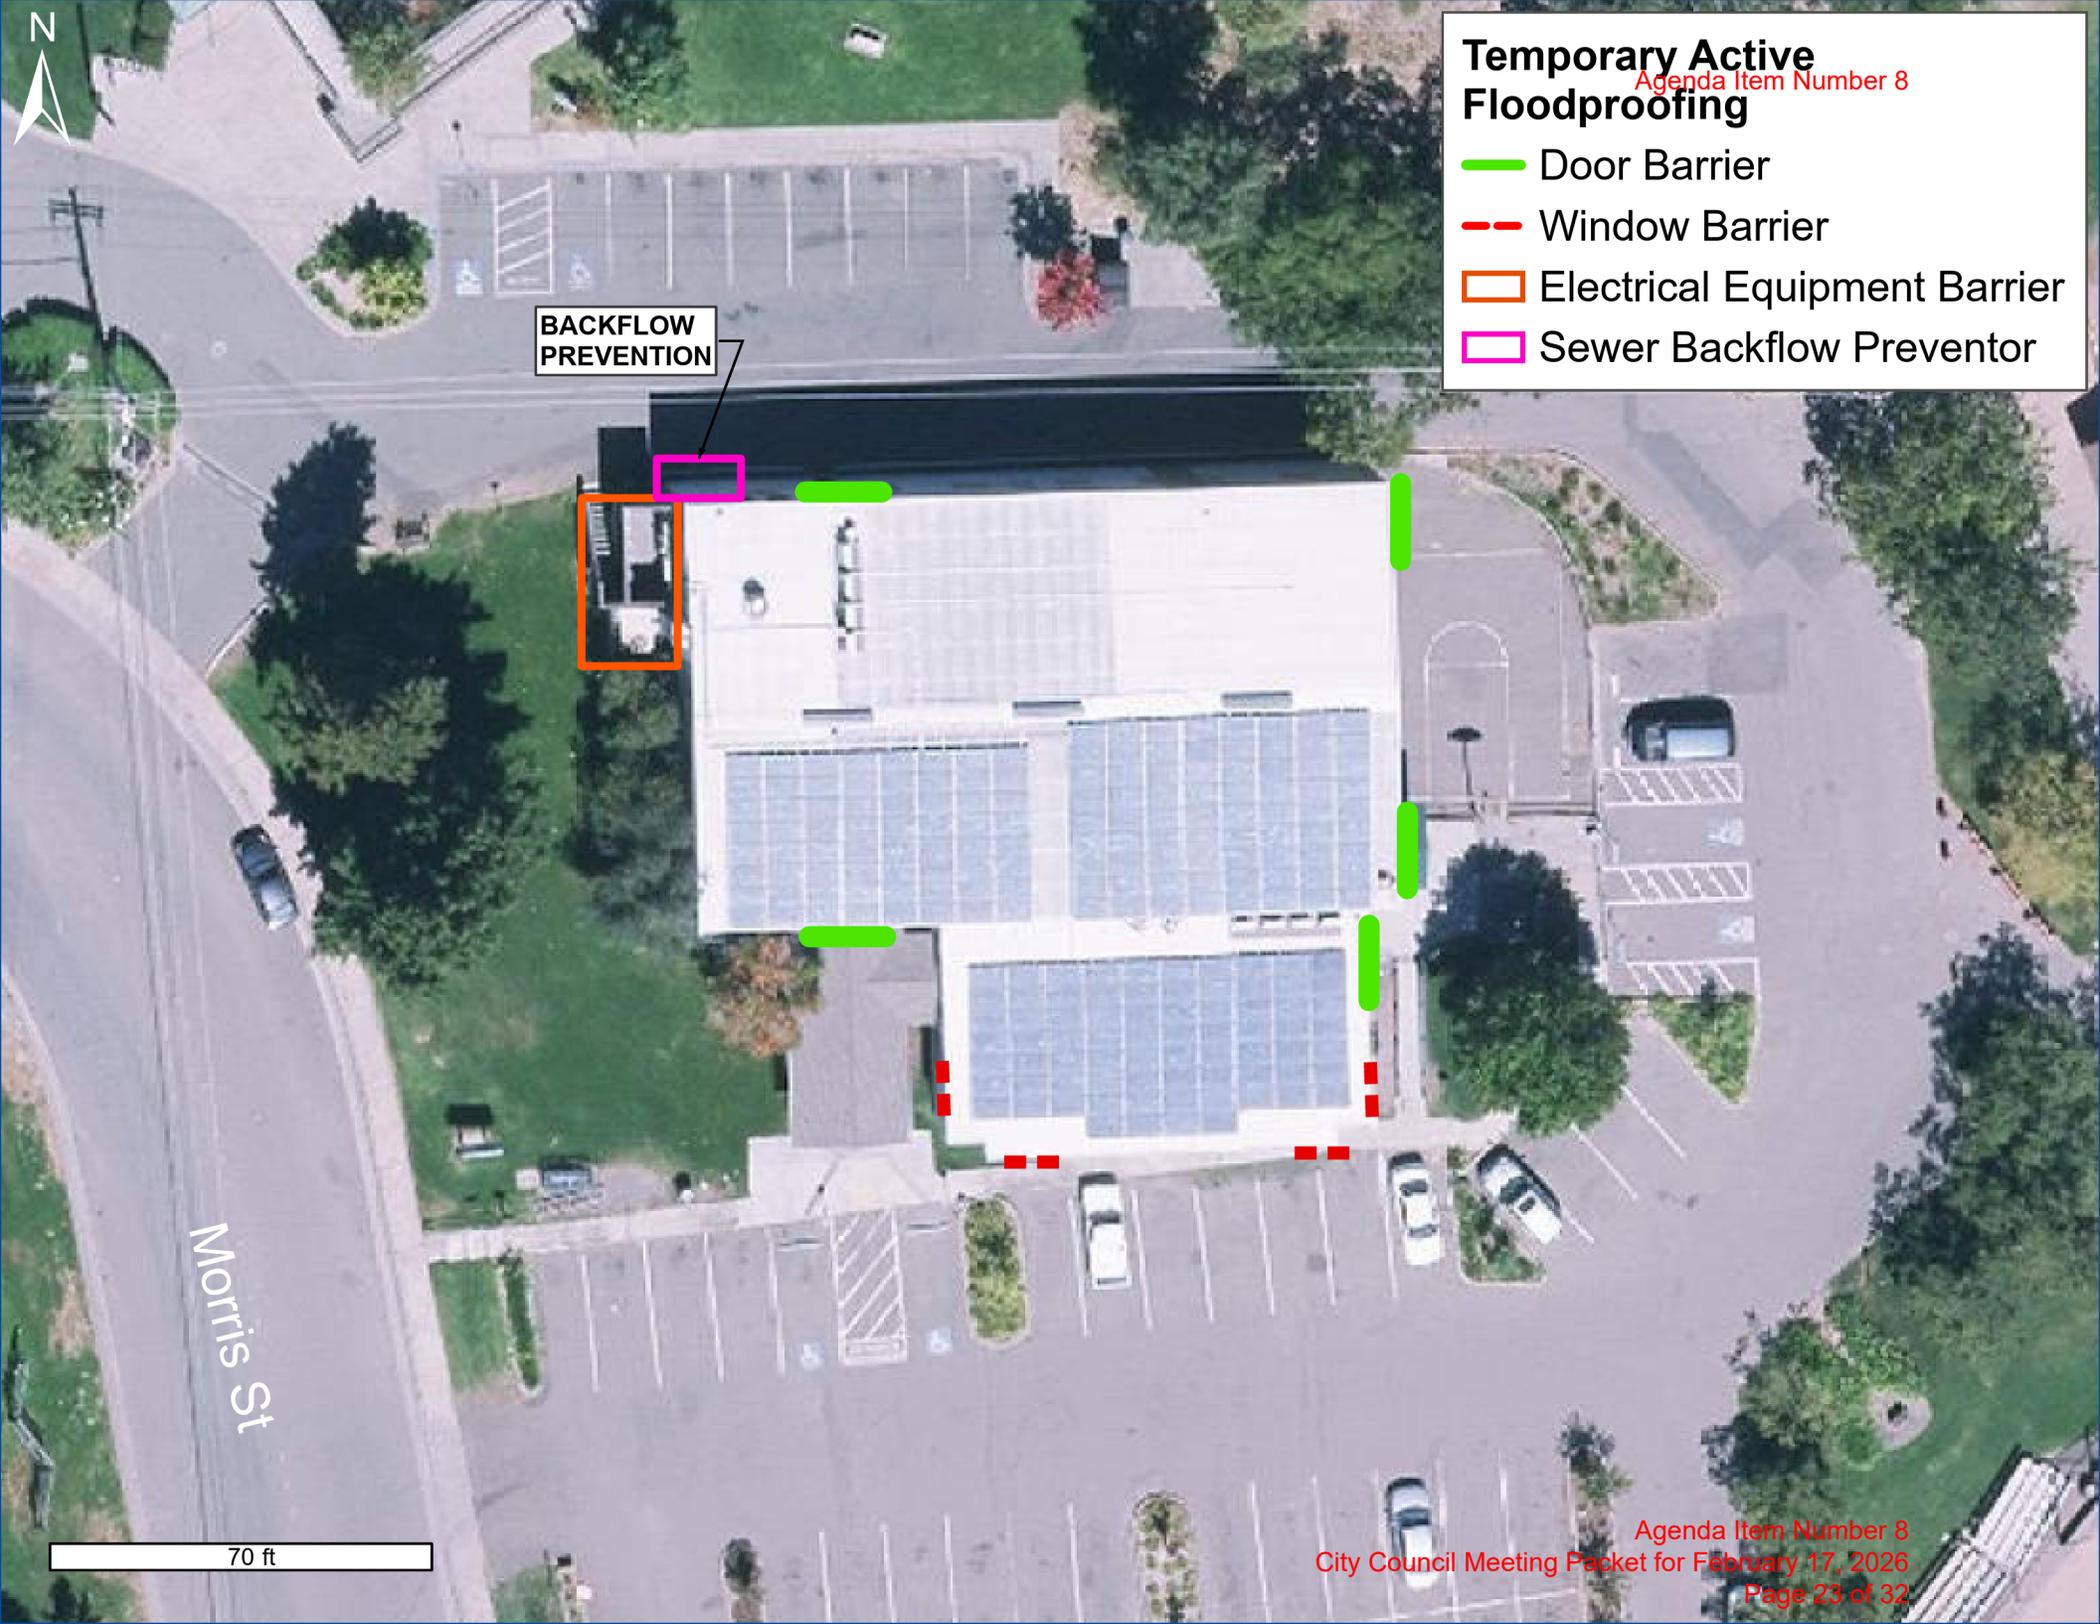
Temporary Active Floodproofing

Sewer Backflow Preventor

**BACKFLOW
PREVENTION**
