DRAFT Technical Memorandum

To	Kari Svanstrom & Dante Del Prete (City of Sebastopol)	MSA No.	2010-01-36
From	Corey Hayes & Jeremy Svehla, PE (GHD)	Task Order No.	27
Reviewed By	Toni Bertolero, PE (GHD)	GHD Project No.	12566276
Project Name	Calder Creek Modifications at Ives Park – Hydrologic and Hydraulic Modeling Assessment

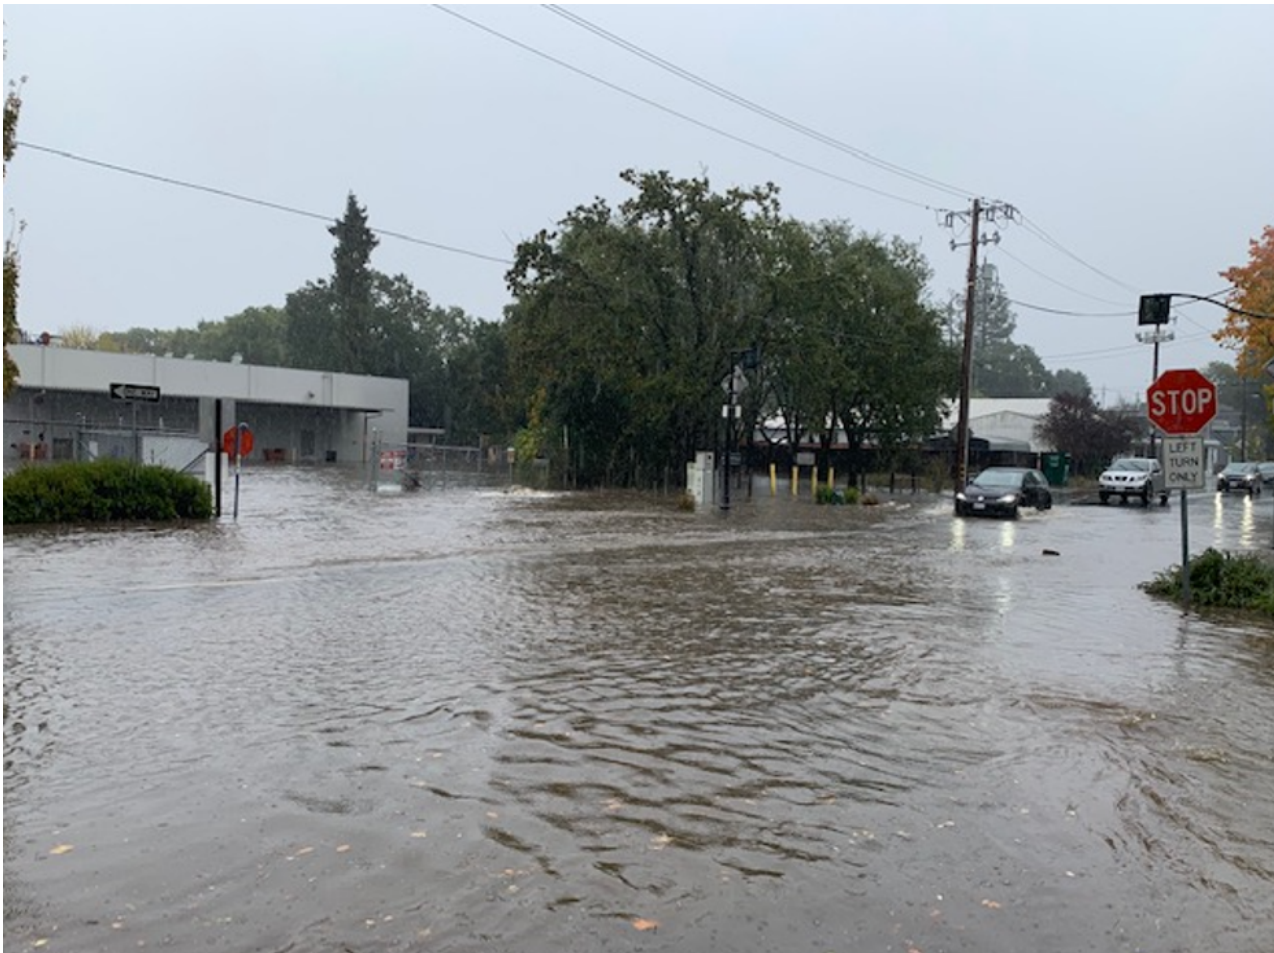
Figure 2 *Calder Creek flooding at Petaluma Avenue during the October 24th, 2021 10-year recurrence interval storm event.*

A significant storm event occurred on October 24, 2021 and caused Calder Creek to flow overbank and flood portions of Petaluma Ave. and adjacent private properties. According to the National Weather Service (NWS, 2022) total precipitation accumulation for that event was 6.09 inches over a 24-hour time period (NWS, 2022 from the Sonoma County Airport Rain Gauge). According to the intensity, duration, frequency data provided by the National Oceanic and Atmospheric Association (NOAA) this event was approximately a 10-year recurrence interval storm event (NOAA, 2022), or an event that has a 10% chance of occurrence in any given year. An image taken near the peak flooding event is provided below (Figure 2).

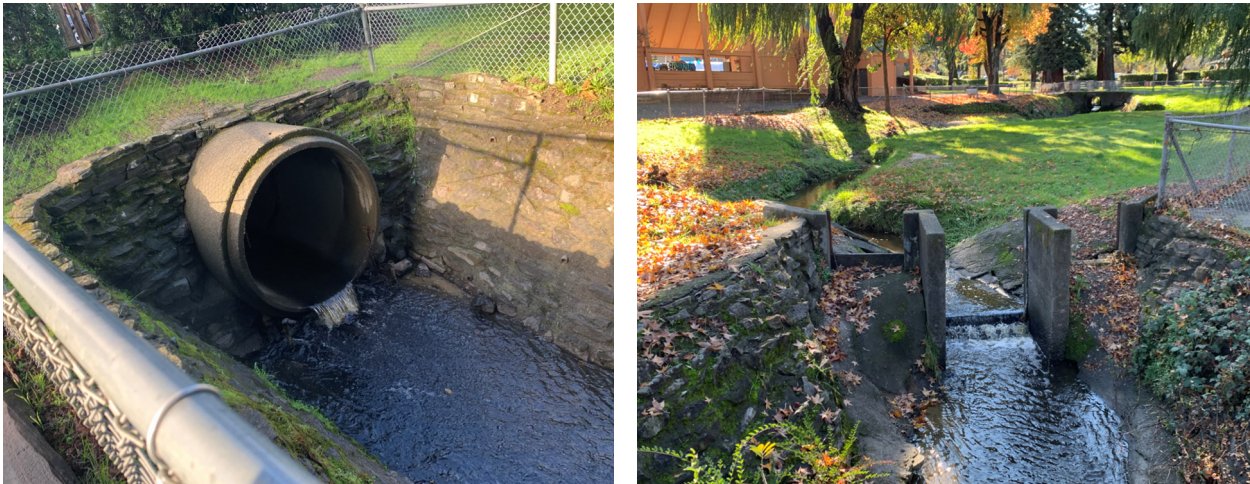
Figure 3 Left: Calder Creek at upstream end of Ives Park (looking toward the southwest); Right: Calder Creek at the central flashboard weir system within the heart of Ives Park.

Calder Creek drains into Ives Park through an existing 60-inch diameter concrete storm drain pipe where flow immediately becomes channelized (Figure 3, left) into a trapezoidal, concrete lined channel with stone surface texturing that extends through Ives Park. Central to Ives Park is a widened, naturalized, earthen portion of the channel with Inset floodplains (also known as in-channel benches consisting of narrow floodplain “benches” which lie 1-2 feet above the existing low flow channel thalweg but below the bankfull width. A single weir and flashboard system downstream to this widened channel was constructed to create a pond feature (Figure 3, right). Overtime, this backwater effect has slowed velocities, which has allowed sediment to accumulate behind the weir structure and collect along the streambed and inset floodplain areas. The flashboard weir was later removed which caused geomorphic response along Reach 1, effective

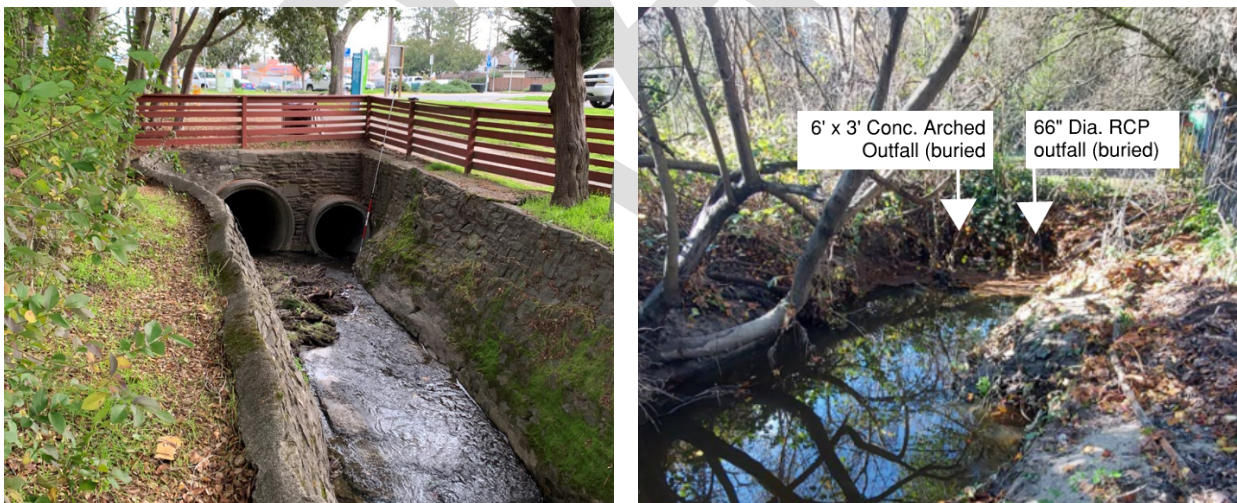
Figure 4: Left: Calder Creek at downstream end of Ives Park at the inlet of the parallel, underground pipes. Right: Calder Creek outfalls at the Laguna De Santa Rosa floodplain.

Reaches 2 and 3 consist of underground storm drain pipes extending from the east end of Ives Park to the outfall at the Laguna de Santa Rosa floodplain. Portions of these pipes lie directly under S High St., S. Main St., and Petaluma Ave. Reach 2 consists of the portion of underground, parallel, reinforced concrete pipe (RCP) between Ives Park and the Junction Structure at S. Main St. Reach 3 consists of the portion of underground pipe that splits once again from the Junction Structure at S. Main St. and runs parallel to the storm drain outfall in the Laguna de Santa Rosa floodplain.

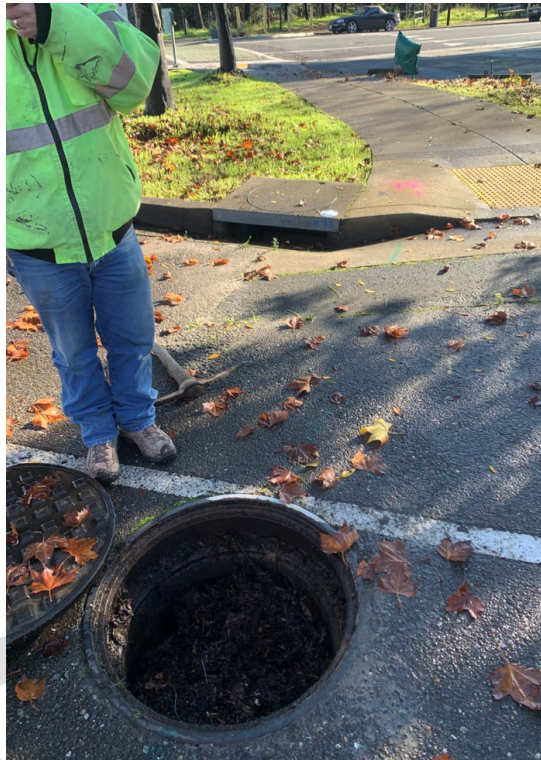
Figure 5 GHD staff at a manhole upstream from Petaluma Ave. with sediment accumulation at the manhole rim along the southern run of Reach 3 along a run of 6'x3' arched concrete conduit.

According to the hydrology study performed by Coastland Civil Engineering (2005), under a sediment-free (unplugged) condition, the Reach 2 storm drainage system has sufficient capacity to convey the 10-year storm. However, because of the large sediment accumulation within Reaches 2 and 3, hydraulic capacity in the system has been significantly reduced resulting in flooding during the 10-year event, especially near the area where Calder Creek crosses Petaluma Ave. (see Figure 2 and Figure 5).

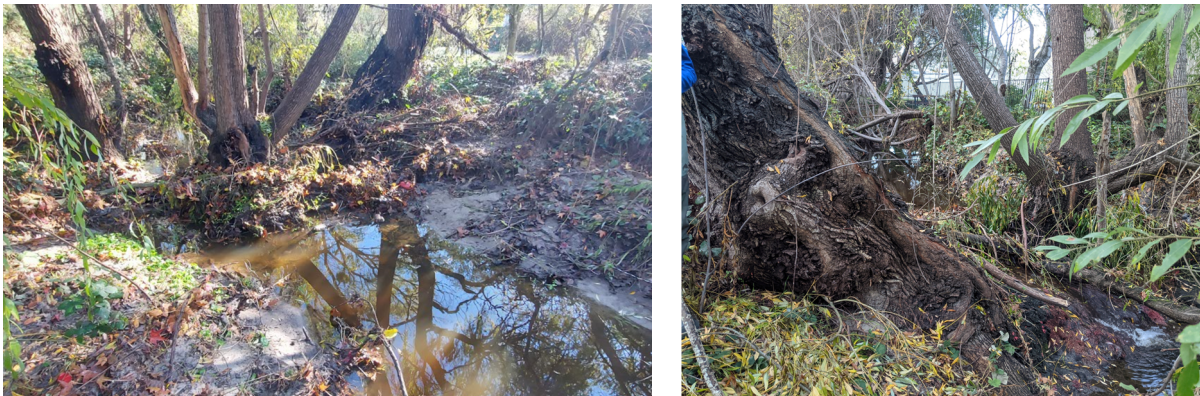
Figure 6 *Non-native Mayten trees in Calder Creek channel approximately 125 ft downstream of the storm drain outfall. Rootwad obstruction causes approximate 1.7' drop in the bed elevation.*

An existing channel rootwad consisting of a large non-native Mayten tree (*Maytenus boaria*) has grown directly in the creek channel, approximately 125-feet downstream of the storm drain outfall (Figure 6). This rootwad has created an obstruction in the conveyance channel and has caused considerable backwater in the storm drain system, slowing water velocities thus allowing sediment to deposit and collect, upstream of the rootwad. Based on on-site investigation by GHD field crew, a considerable quantity of sediment was observed at a manhole along the southern leg of Reach 3, just upstream of the Calder / Petaluma Ave. crossing (Figure 5).

The rootwad creates an approximate 1.7-foot drop in creek bed elevation. Calder Creek then flows toward the Laguna de Santa Rosa through a series of shallow channels. For this report, geomorphic and hydraulic conditions were characterized to the footbridge at the Joe Rodota Trail.

Proposed Condition A removes the single rootwad obstruction and lowers the bed elevation 1.7 feet between the storm drain outfall and rootwad (see Figure 6). The rootwad occurs approximately 100 feet downstream of the Calder Creek storm drain outfall. Given the backwater condition created by the rootwad, removal of rootwad and lowering of the channel could allow some accumulated sediment in the upstream storm drain pipes to remobilize and therefore, an additional assumption was made for this scenario that accounted for approximately 1 vertical foot of stored sediment remobilizing during the first high winter flow, slightly increasing the storm drain capacity. This model condition assumed the remobilized sediment would transport out of the system and redistribute throughout the Laguna.
